## **MINUTES OF THE MEETING OF THE **PROPERTY COMMITTEE** HELD AT THE DRILL HALL ON TUESDAY 18<sup>th</sup> August 2026 AT 2PM**

**8. To Receive Update on Property Forward Maintenance Plan Project**

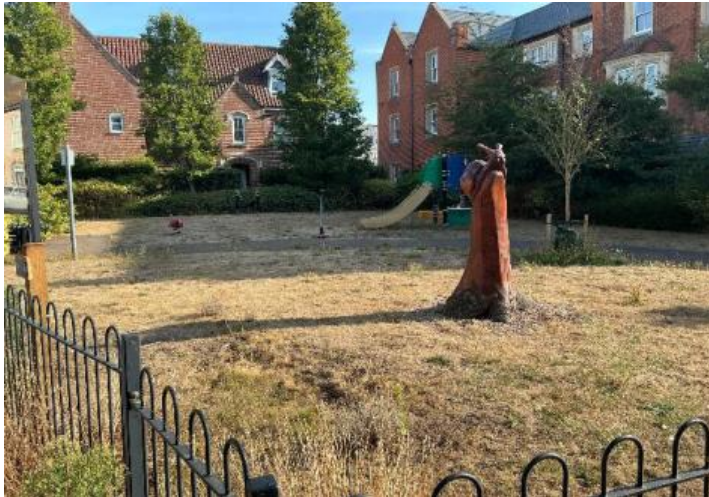
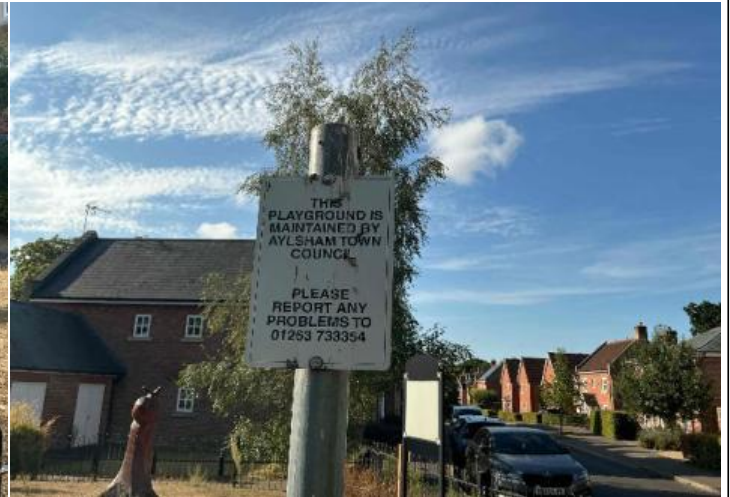
**Item:** Ancillary Items - Site General  
**Manufacturer:** Owner/Operator

**Finding:** It is recommended that signage, with information including the site address, contact information for maintenance issues and emergency contact details are provided for the facility

**Action:** Provide in accordance with the recommendations

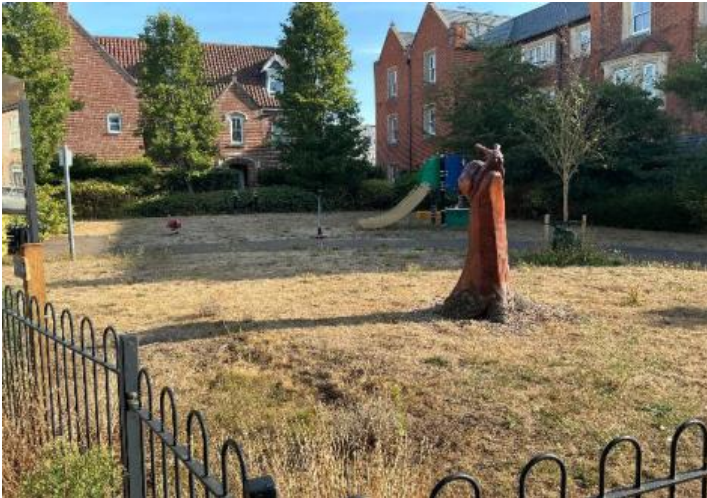
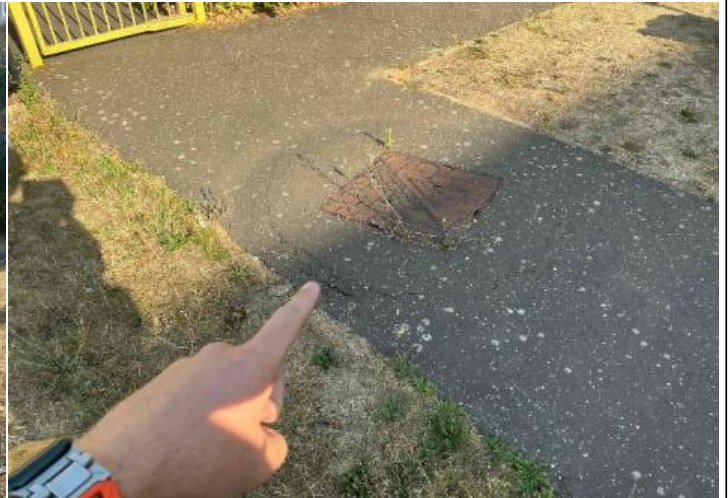
**Item:** Ancillary Items - Site General  
**Manufacturer:** Owner/Operator

**Finding:** There is some minor damage to the surface

**Action:** Monitor for any further deterioration and repair as required

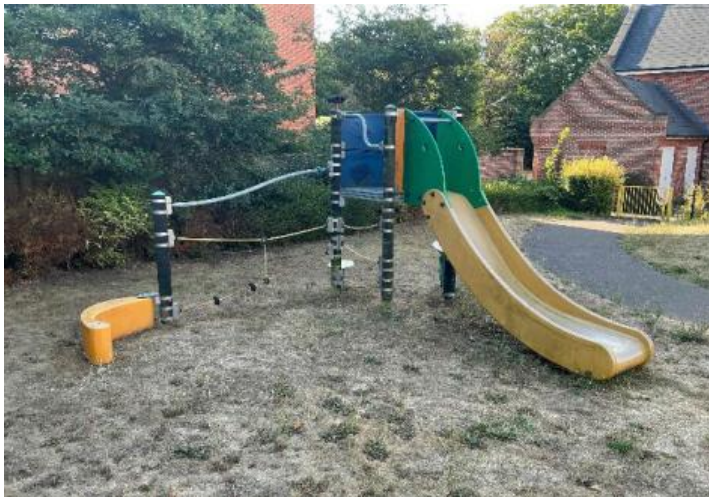
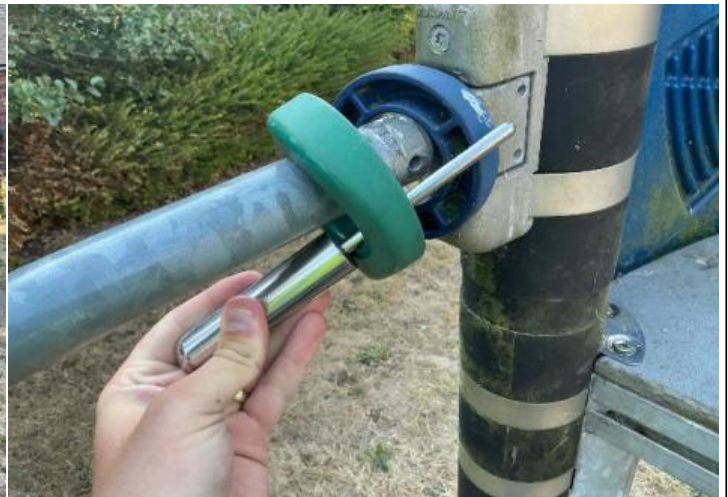
**Item:** Activity Equipment - Multi Play (Junior)  
**Manufacturer:** Kompan Ltd

**Finding:** There is/are finger entrapment/s in the rings and the item fails to meet the requirements of BS EN 1176 Part 1 4.2.7.6 Entrapment of fingers

**Action:** Monitor - No remedial work recommended

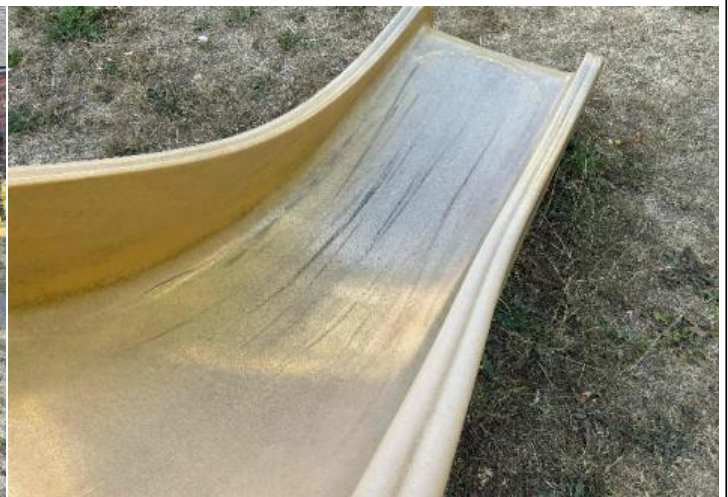
**Item:** Activity Equipment - Multi Play (Junior)  
**Manufacturer:** Kompan Ltd

**Finding:** There is minor damage to the slide surface

**Action:** Monitor for any further deterioration and repair as required

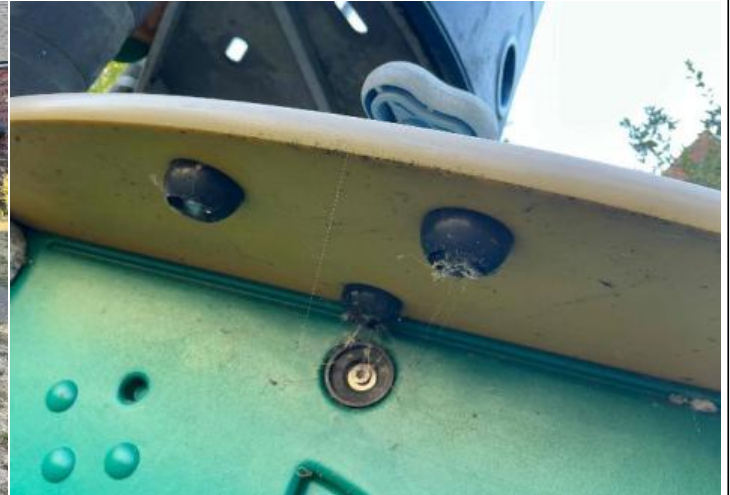
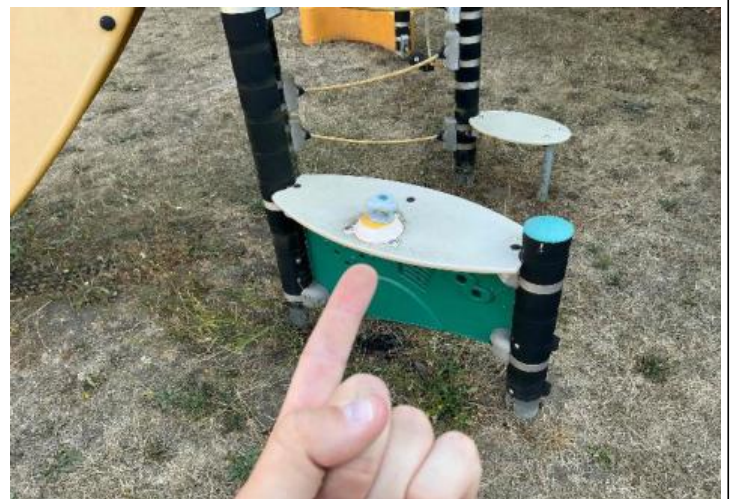
**Item:** Activity Equipment - Multi Play (Junior)  
**Manufacturer:** Kompan Ltd

**Finding:** Bolt cap cover/s missing or damaged

**Action:** Replace

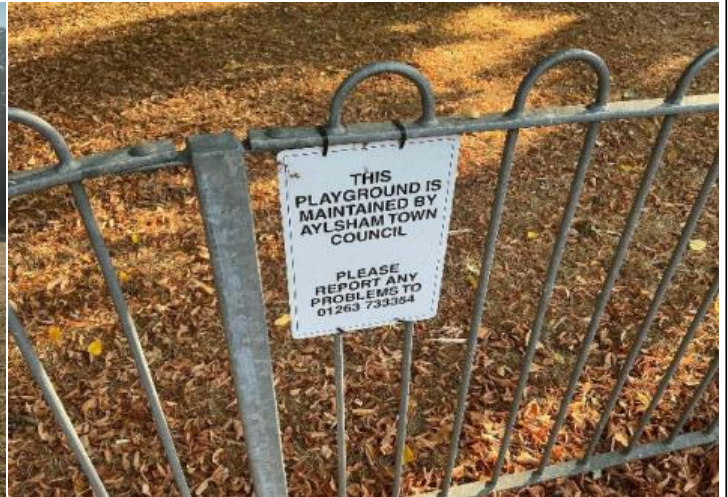
**Item:** Ancillary Items - Site General  
**Manufacturer:** Owner/Operator

**Finding:** It is recommended that signage, with information including the site address, contact information for maintenance issues and emergency contact details are provided for the facility

**Action:** Provide in accordance with the recommendations

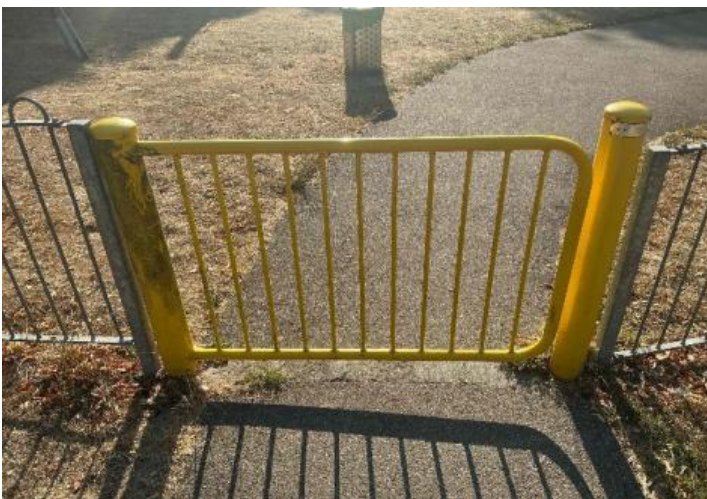
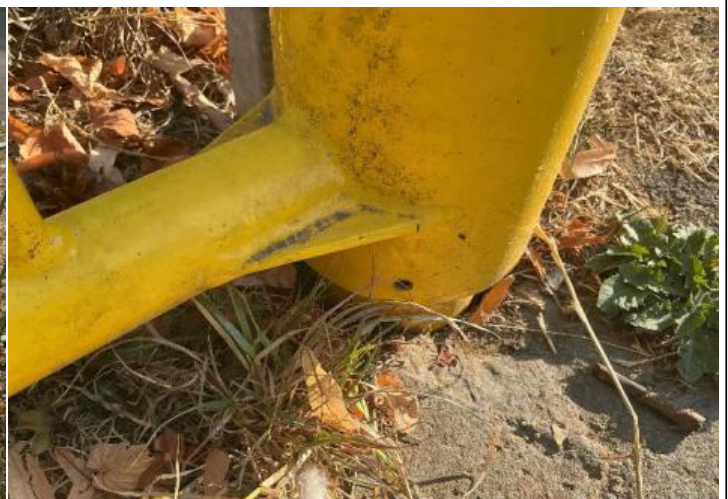
**Item:** Gates - Gate - Self Closing  
**Manufacturer:** Medway Gate Co.

**Finding:** There is or are fixings missing on the item

**Action:** Replace all missing fixings

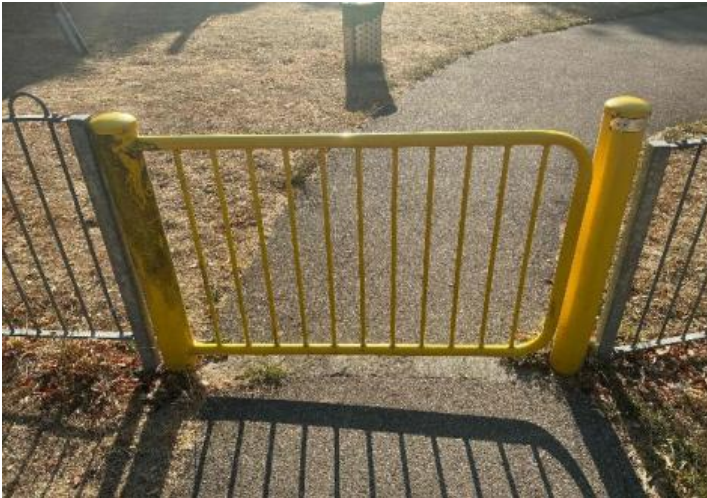
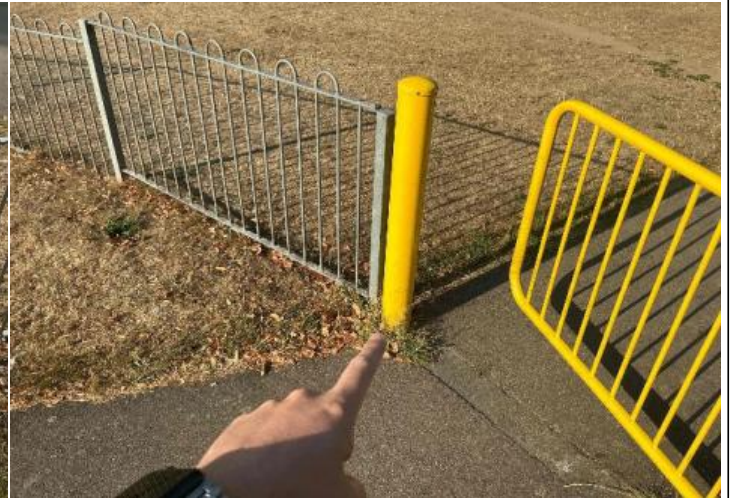
**Item:** Gates - Gate - Self Closing  
**Manufacturer:** Medway Gate Co.

**Finding:** The item is slightly loose in its foundations

**Action:** Monitor for any further deterioration and repair as required

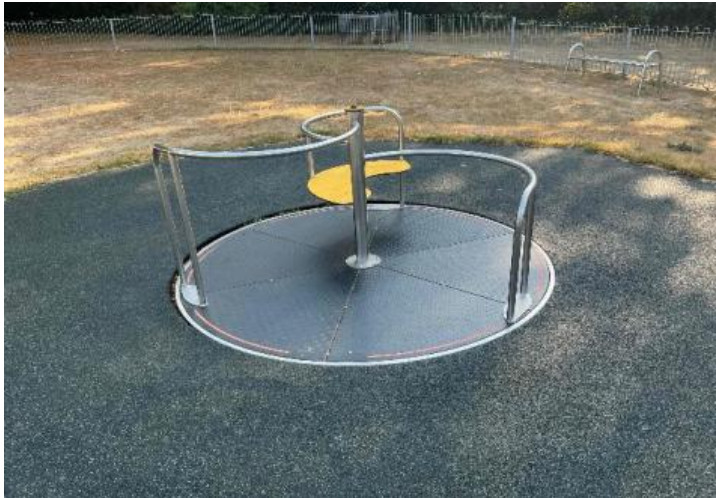
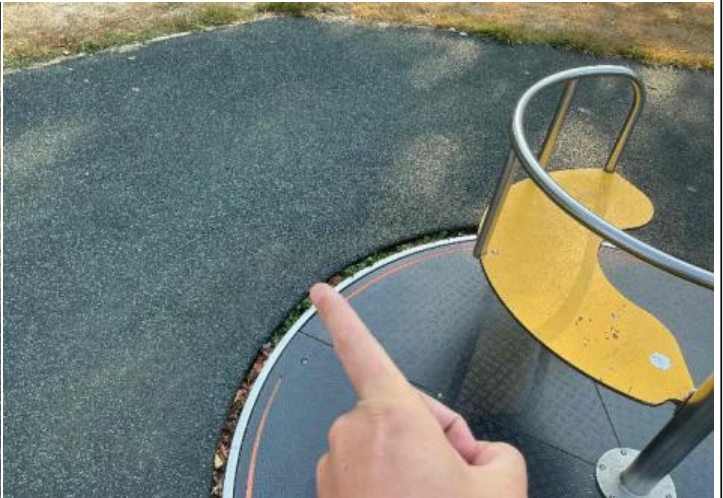
**Item:** Rotor Play - Inclusive Roundabout  
**Manufacturer:** Playdale Playgrounds Ltd

**Finding:** The surface is lifting at the edges and creating trip points **Action:** Repair perimeter of surfacing to remove trip points

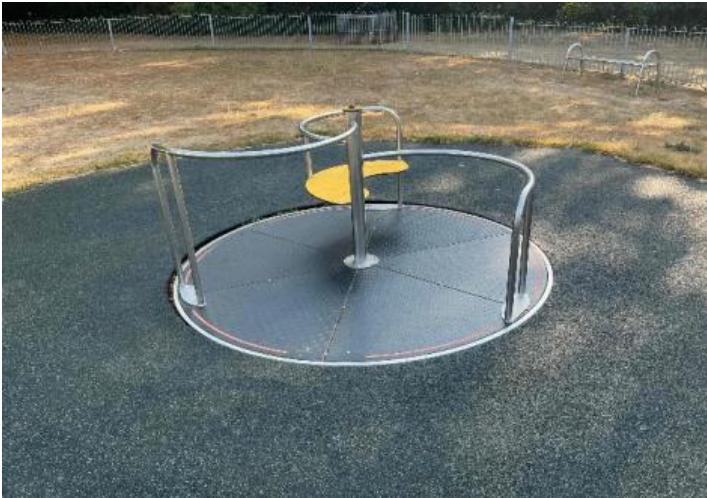
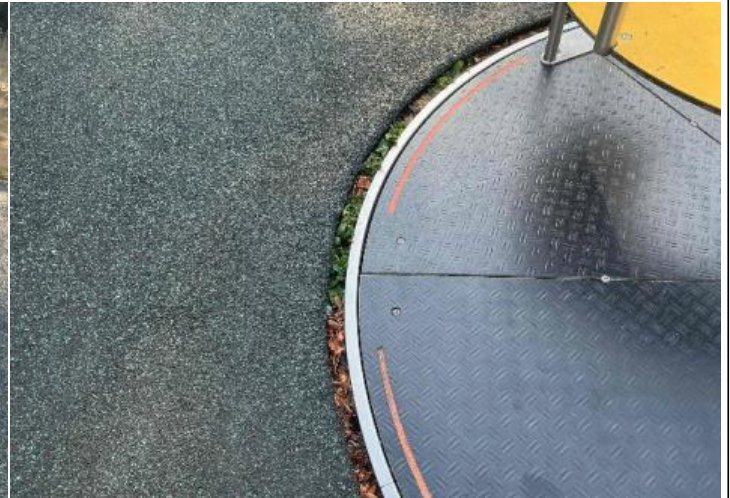
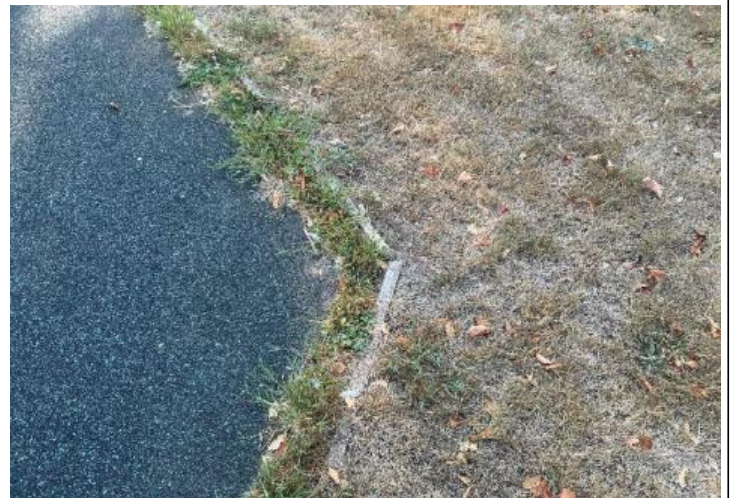
**Item:** Rotor Play - Inclusive Roundabout  
**Manufacturer:** Playdale Playgrounds Ltd

**Finding:** There are significant gaps (over 30mm) between the surface and the edging or between the joints in the surface; these are large enough for a small foot to enter

**Action:** Repair surfacing

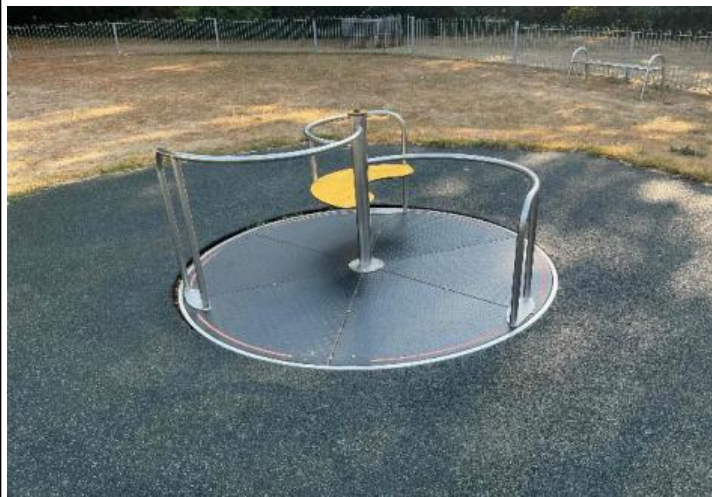
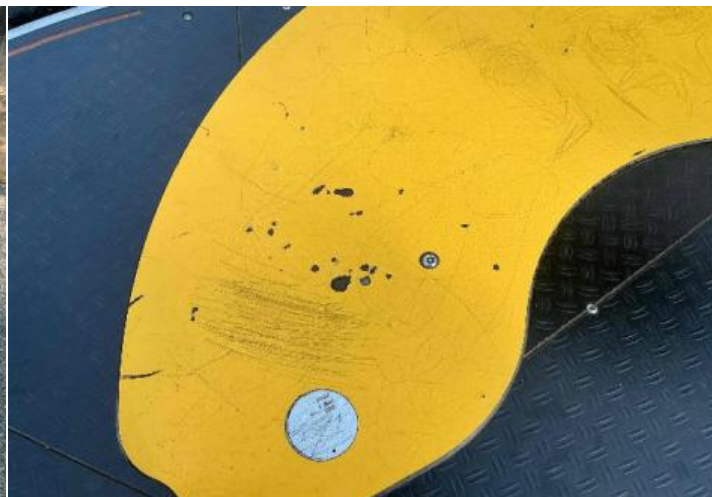
**Item:** Rotor Play - Inclusive Roundabout  
**Manufacturer:** Playdale Playgrounds Ltd

**Finding:** The item has been damaged

**Action:** Monitor for any further deterioration and replace as required

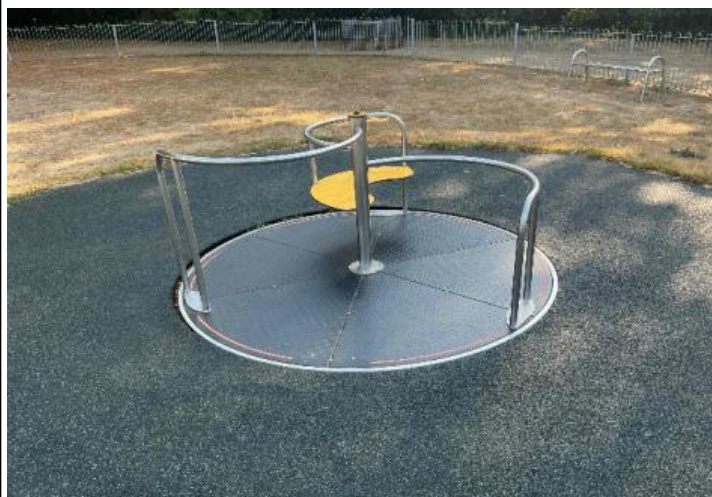
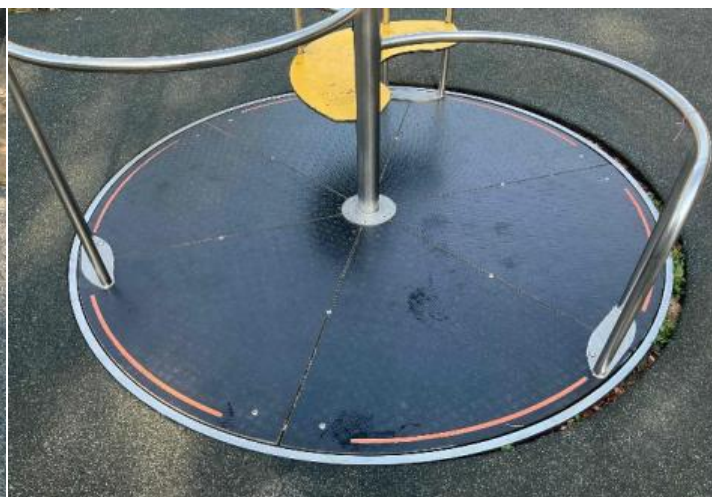
**Item:** Rotor Play - Inclusive Roundabout  
**Manufacturer:** Playdale Playgrounds Ltd

**Finding:** There is some play / movement in the platform and the inspector has some concerns about the potential for failure or entrapment, however it is not possible to tell the extent of the issue without dismantling checks

**Action:** Strip down and check in accordance with manufacturer instructions

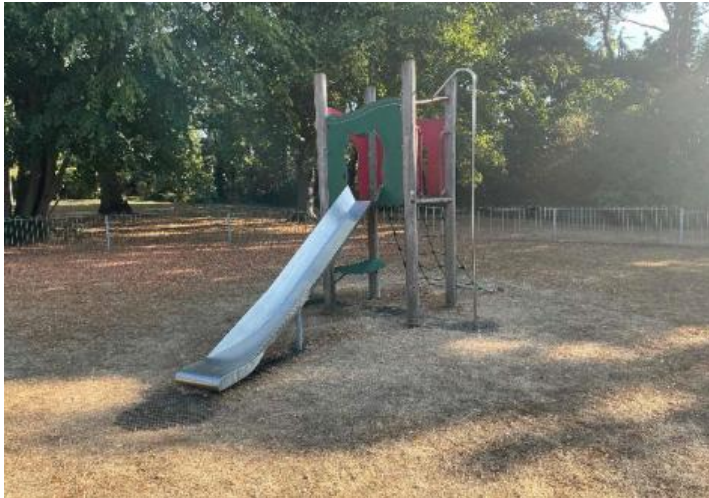
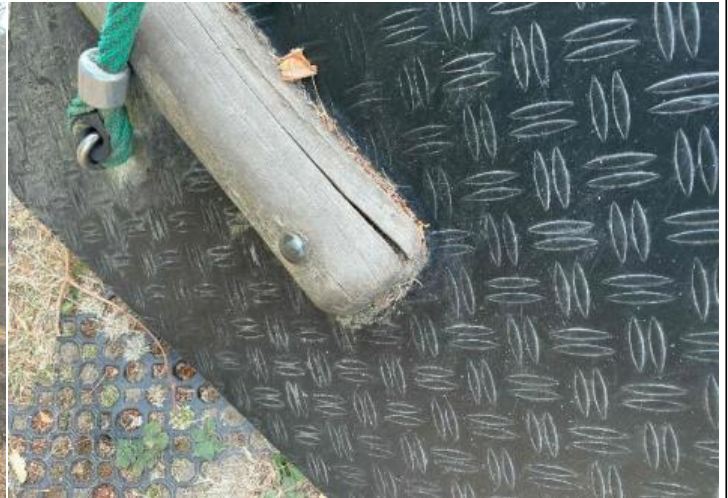
**Item:** Activity Equipment - Multi Play (Junior)  
**Manufacturer:** Playdale Playgrounds Ltd

**Finding:** There is a split in the tread

**Action:** Monitor for any further deterioration and replace as required

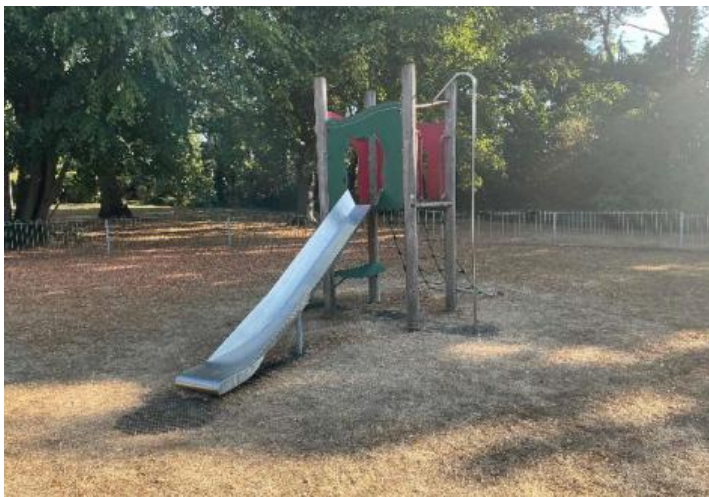
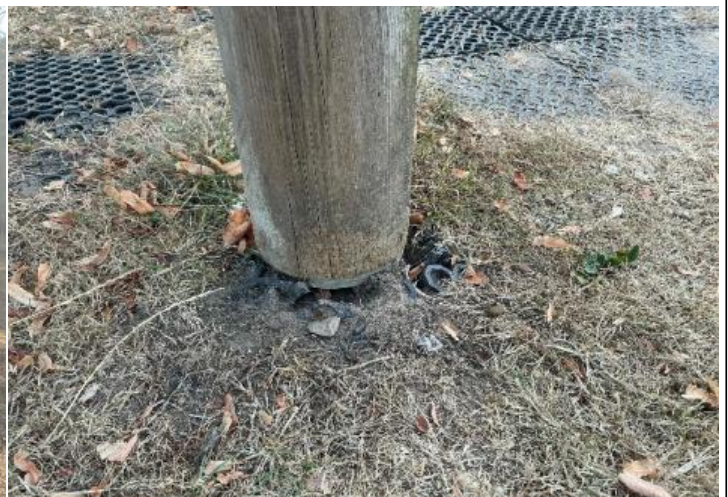
**Item:** Activity Equipment - Multi Play (Junior)  
**Manufacturer:** Playdale Playgrounds Ltd

**Finding:** There is some strimmer / machinery damage apparent on the posts, this can penetrate the preservative applied to the timber and accelerate the rotting process

**Action:** Monitor for any deterioration (rot) and replace as required

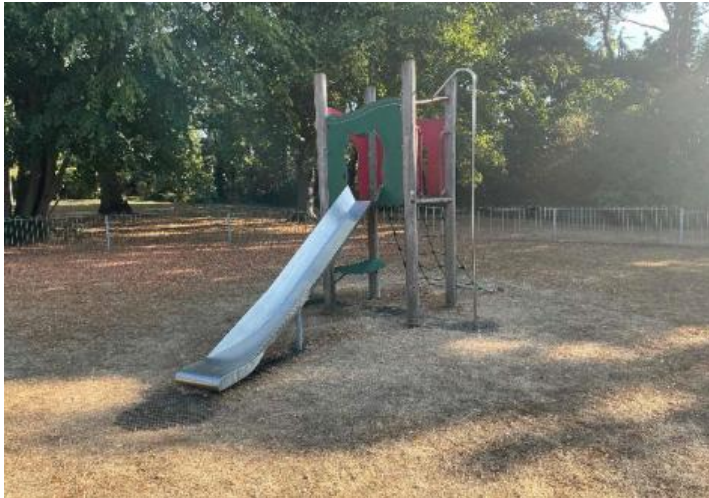
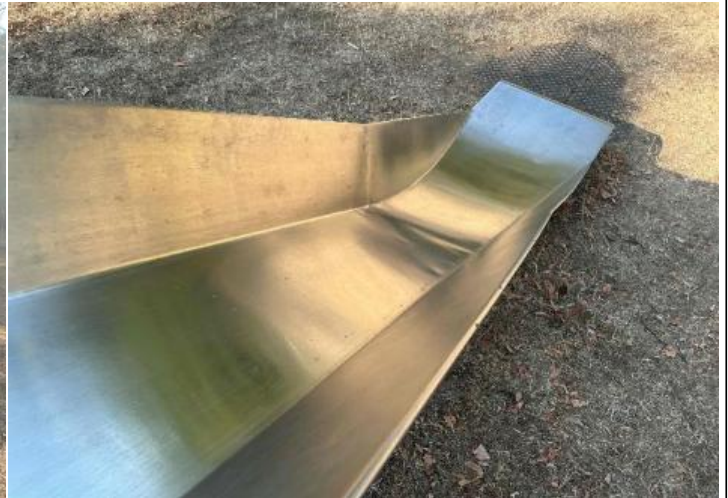
**Item:** Activity Equipment - Multi Play (Junior)  
**Manufacturer:** Playdale Playgrounds Ltd

**Finding:** There are a number of dents in the slide surface

**Action:** Monitor for any further deterioration and repair as required

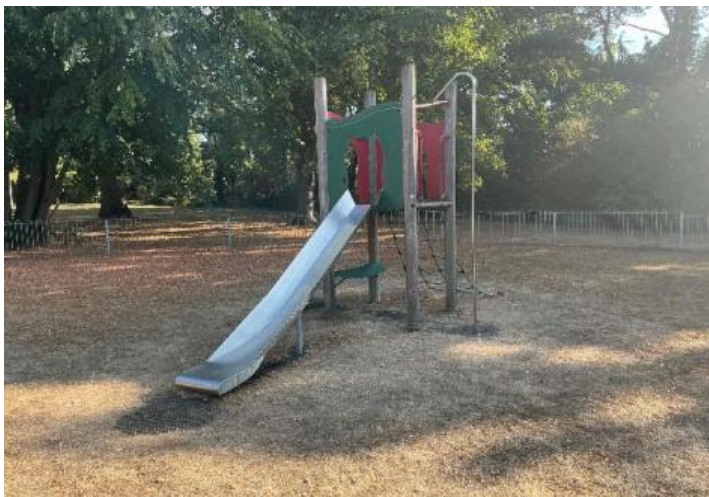
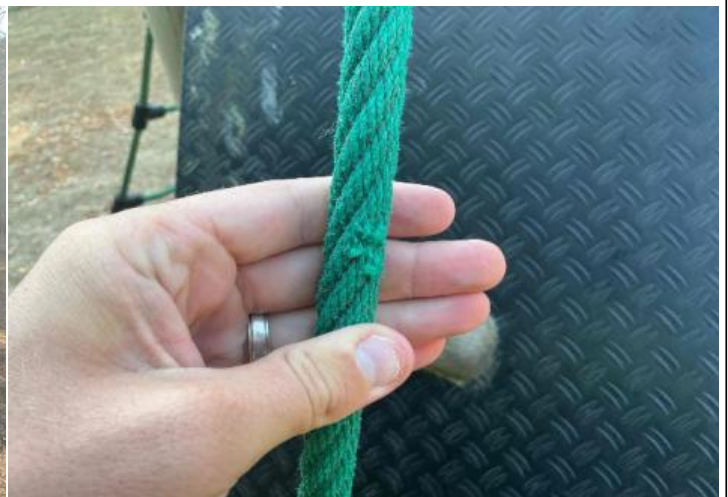
**Item:** Activity Equipment - Multi Play (Junior)  
**Manufacturer:** Playdale Playgrounds Ltd

**Finding:** The ropes/nets are worn/damaged in places

**Action:** Monitor for any further deterioration and repair or replace as required

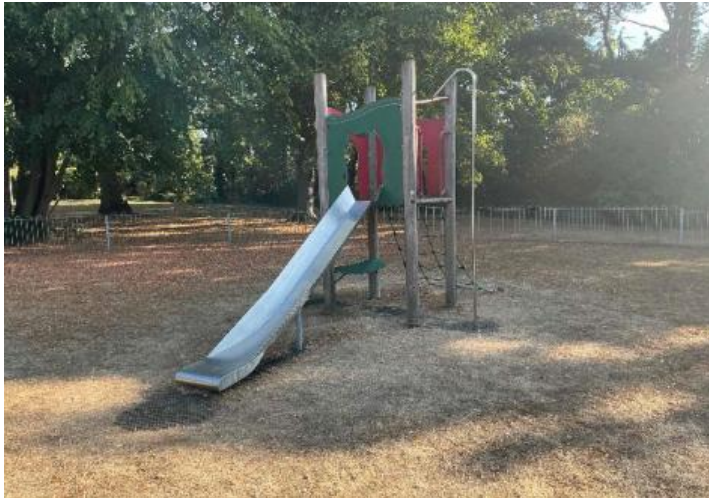
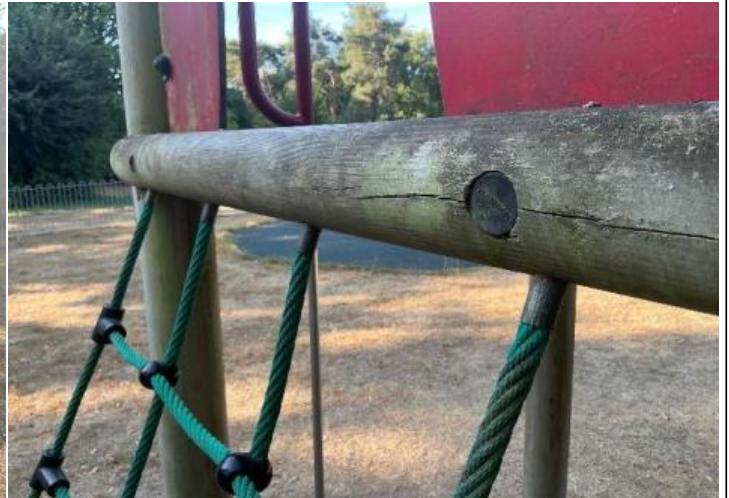
**Item:** Activity Equipment - Multi Play (Junior)  
**Manufacturer:** Playdale Playgrounds Ltd

**Finding:** A number of rope connection fixing(s) have worked loose  
**Action:** Secure all loose fixings

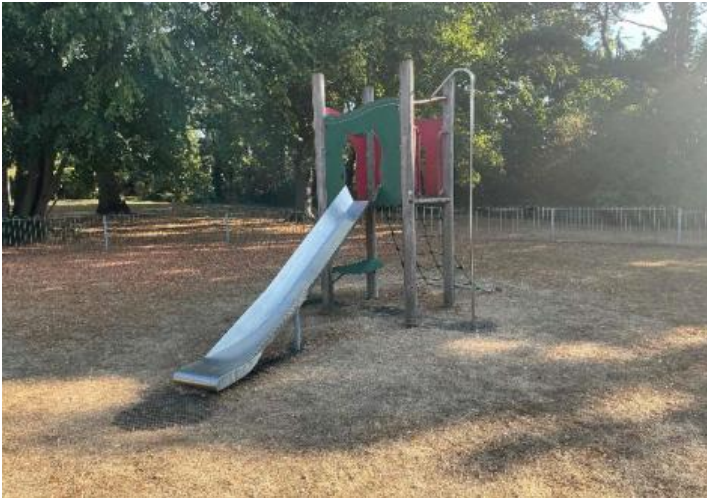
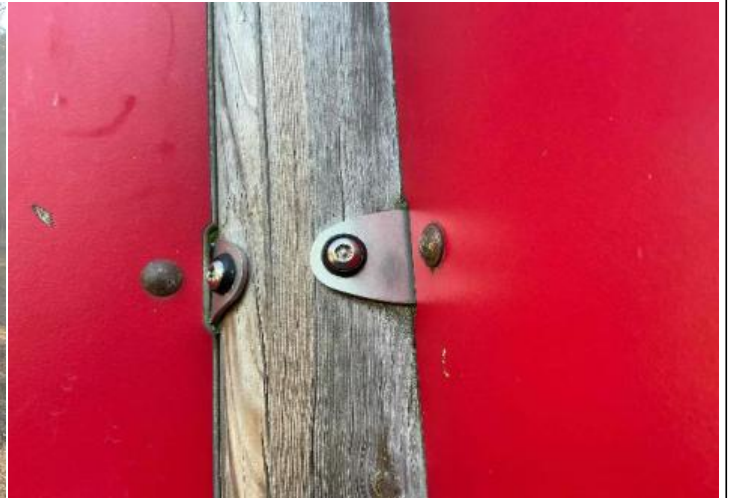
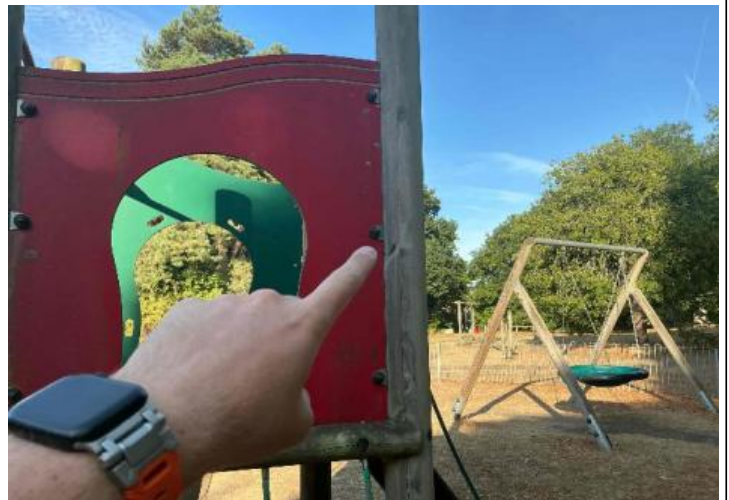
**Item:** Activity Equipment - Multi Play (Junior)  
**Manufacturer:** Playdale Playgrounds Ltd

**Finding:** A number of fixing(s) have worked loose

**Action:** Secure all loose fixings

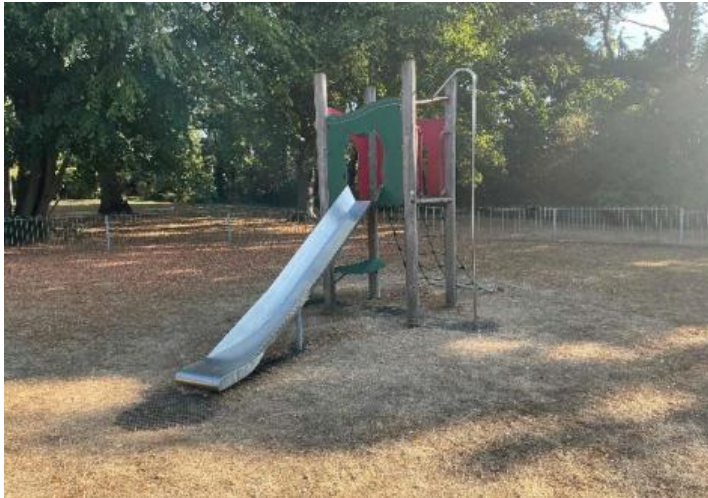
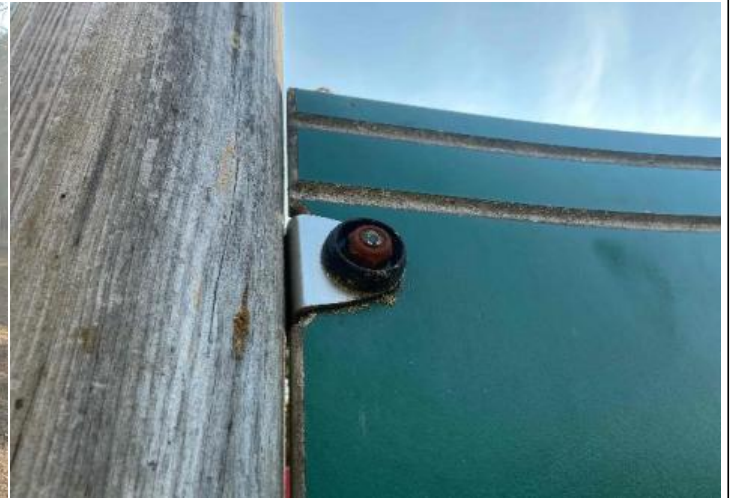
**Item:** Activity Equipment - Multi Play (Junior)  
**Manufacturer:** Playdale Playgrounds Ltd

**Finding:** Bolt cap cover/s missing or damaged

**Action:** Replace

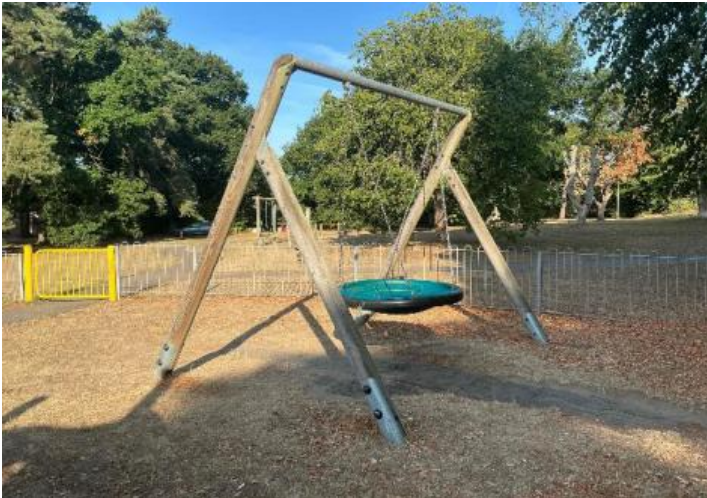
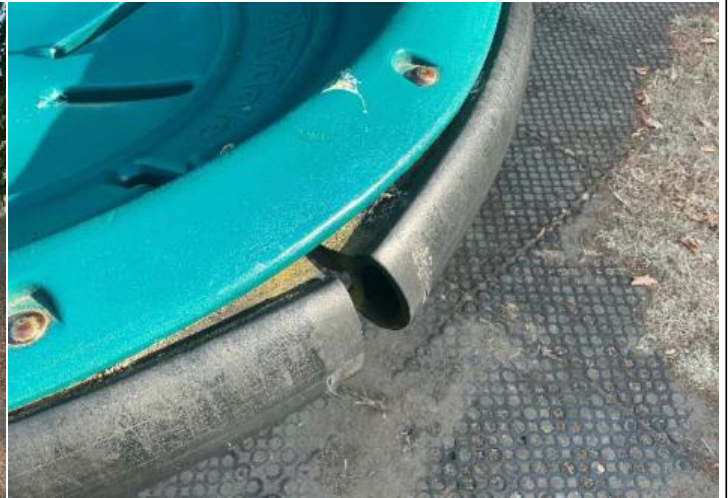
**Item:** Swings - Basket Swing - Type 1  
**Manufacturer:** Playdale Playgrounds Ltd

**Finding:** The joint collar is missing

**Action:** Replace

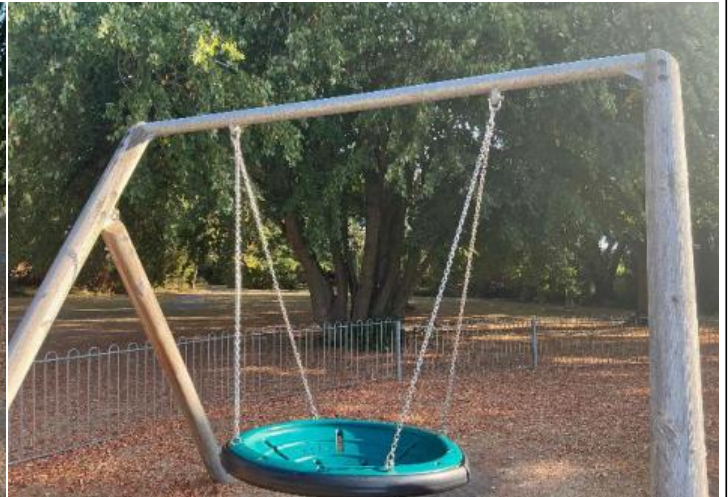
**Item:** Swings - Basket Swing - Type 1  
**Manufacturer:** Playdale Playgrounds Ltd

**Finding:** Swings of this design should have a secondary safety mechanism fitted to prevent collapse of the seat in the regularly event of a joint failure to comply with BS EN 1176 Part 2, however this swing was installed prior to the standards being updated in 2018 and the manufacturer has confirmed that the joint was independently cycle tested by BSi

**Action:** Monitor use and check the joint and fixing security

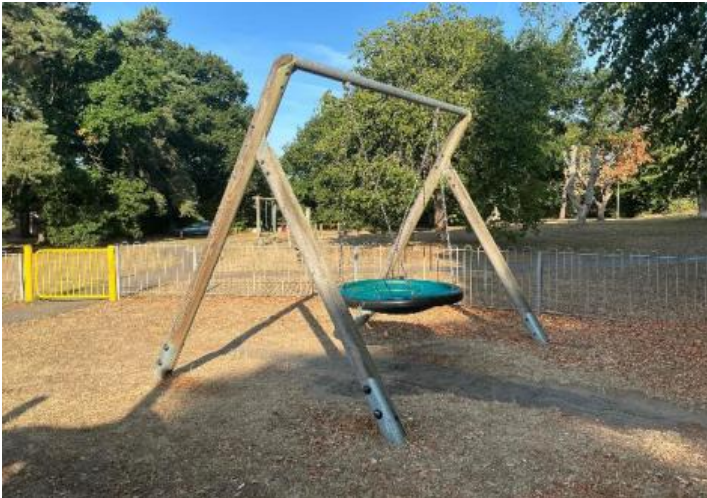
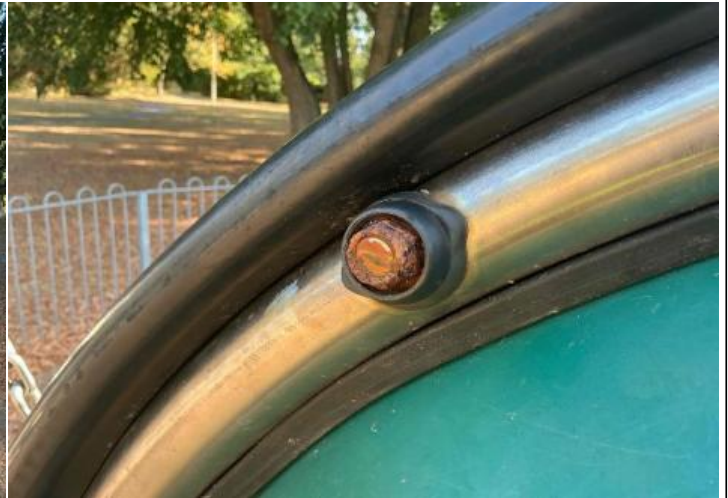
**Item:** Swings - Basket Swing - Type 1  
**Manufacturer:** Playdale Playgrounds Ltd

**Finding:** There are caps missing from the underside of the seats **Action:** Replace missing caps under the seats

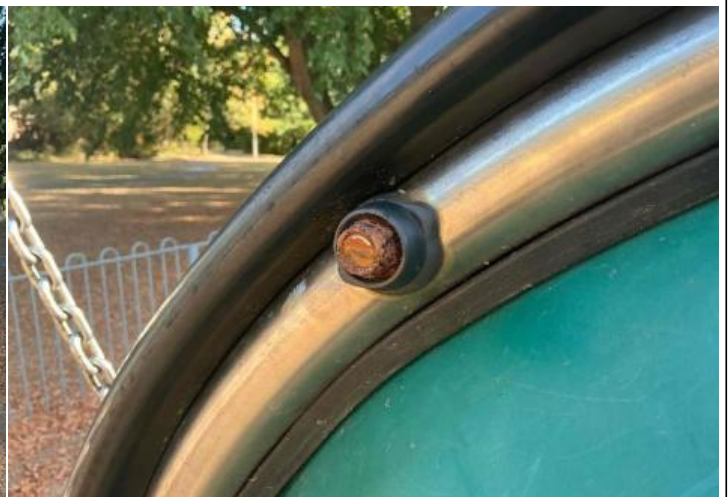
**Item:** Swings - Basket Swing - Type 1  
**Manufacturer:** Playdale Playgrounds Ltd

**Finding:** The fixings have corroded excessively **Action:** Replace all corroded fixings

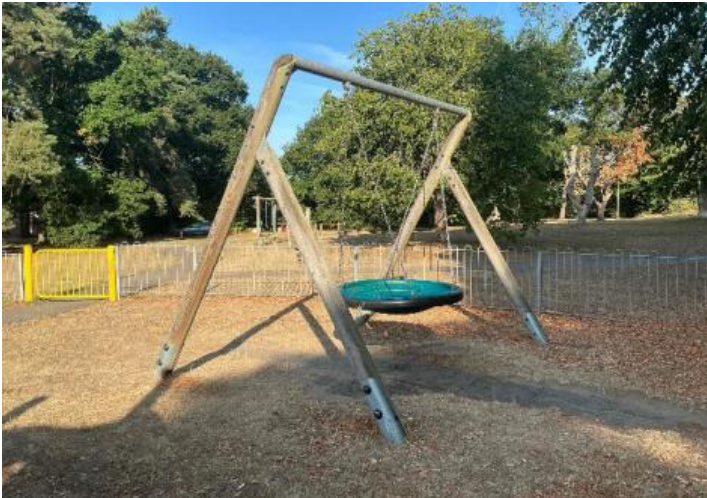
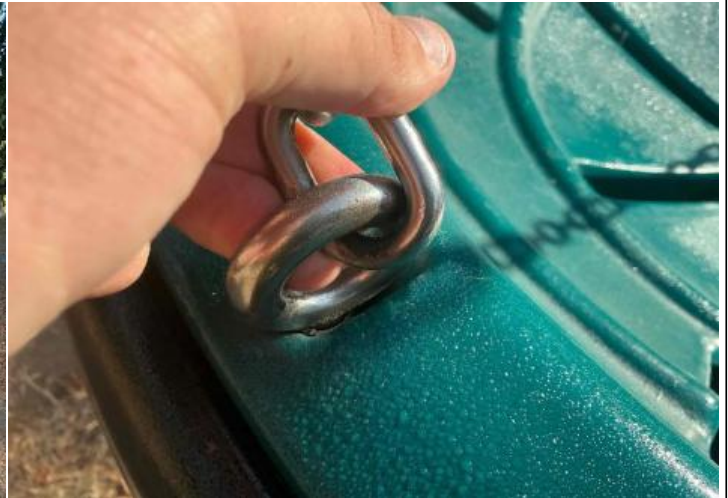
**Item:** Swings - Basket Swing - Type 1  
**Manufacturer:** Playdale Playgrounds Ltd

**Finding:** There is some notable evidence of chain wear

**Action:** Monitor for any further deterioration and replace when 40% worn

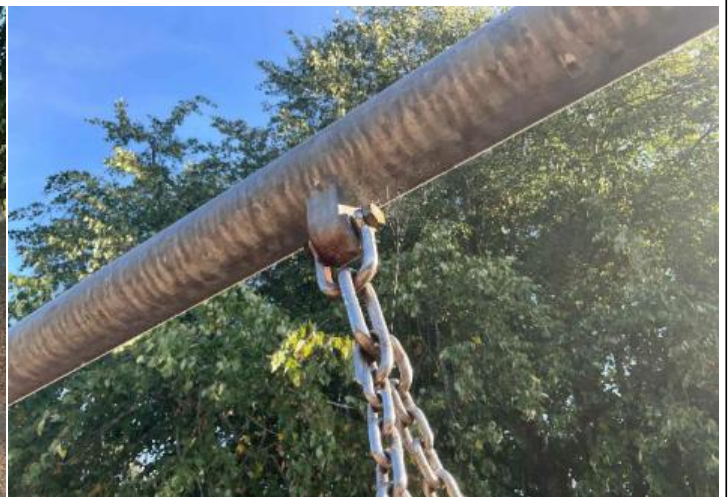
**Item:** Swings - Basket Swing - Type 1  
**Manufacturer:** Playdale Playgrounds Ltd

**Finding:** There is some wear to the shackles

**Action:** Monitor for any further deterioration and replace when 40% worn

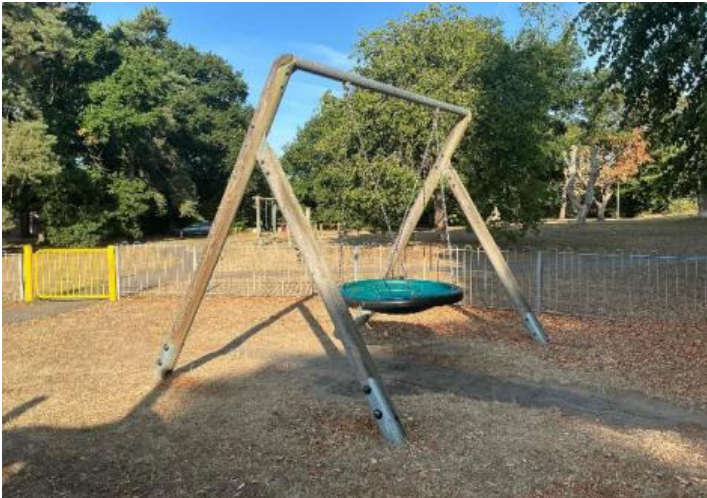
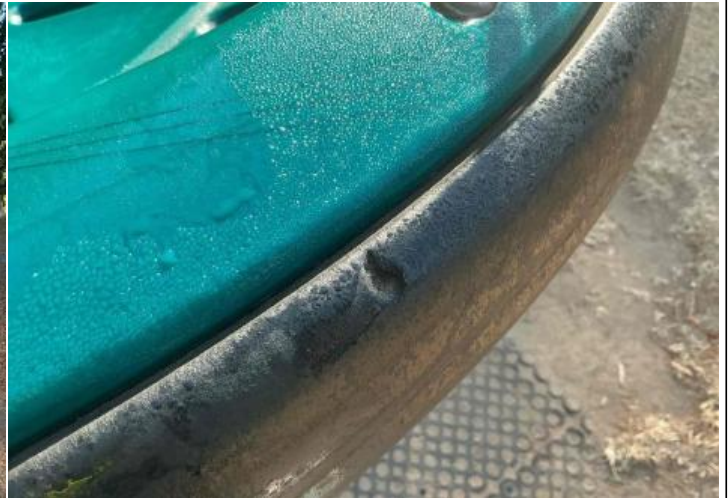
**Finding:** The seat has minor damage or wear

**Action:** Monitor for any further deterioration and replace as required

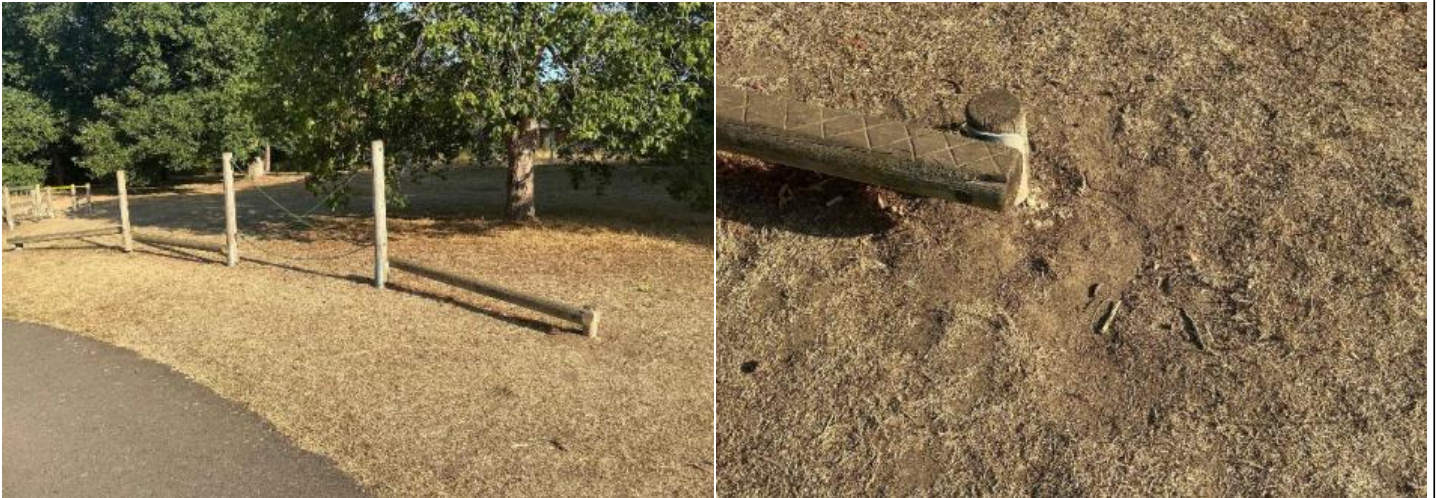
**Finding:** The surface has eroded in some areas and may be slippery in wet conditions  
**Action:** Reinstate the surface

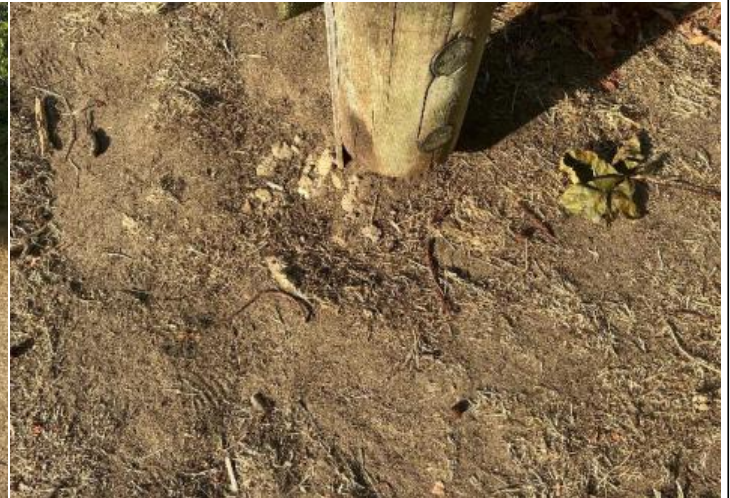
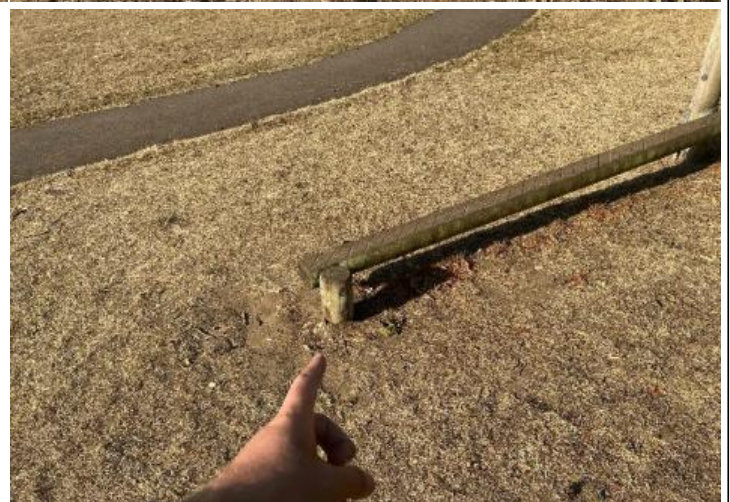
**Finding:** The surface has eroded and the foundations are exposed

**Action:** Reinstall surrounding surfaces to cover the foundations

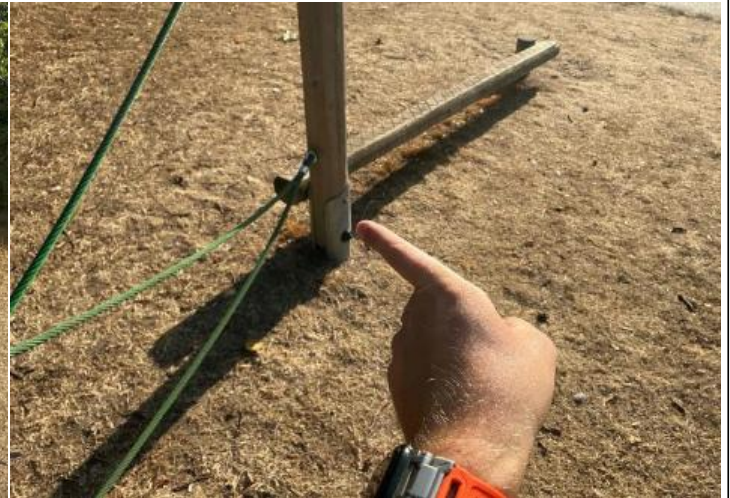
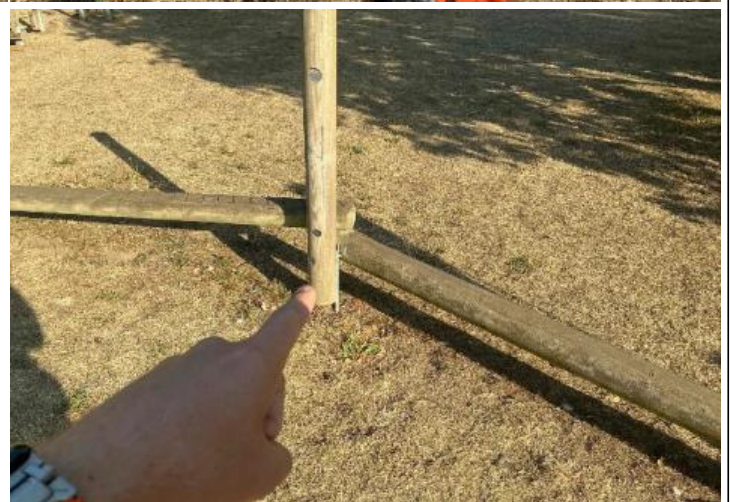
**Finding:** A number of fixing(s) have worked loose

**Action:** Secure all loose fixings

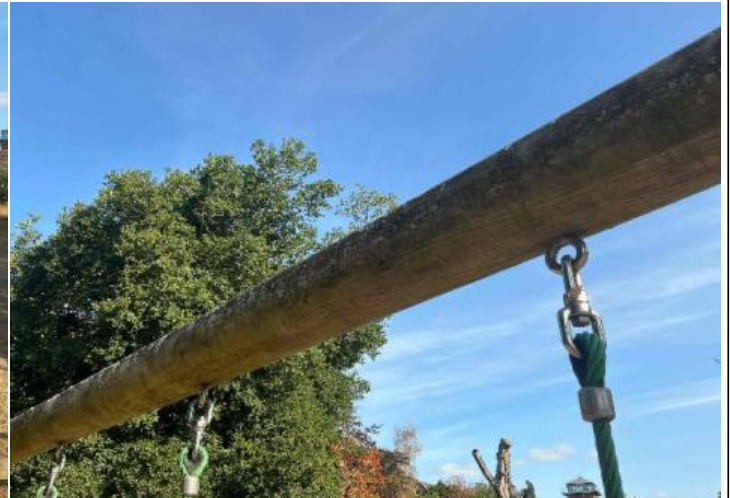
**Finding:** There is algae or moss on the surface of the equipment which can lead to the onset of rot

**Action:** Clean and treat appropriately and monitor condition of the timber

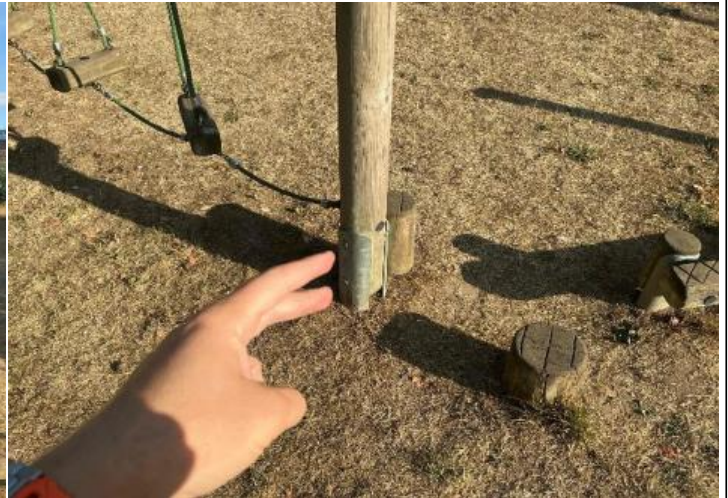
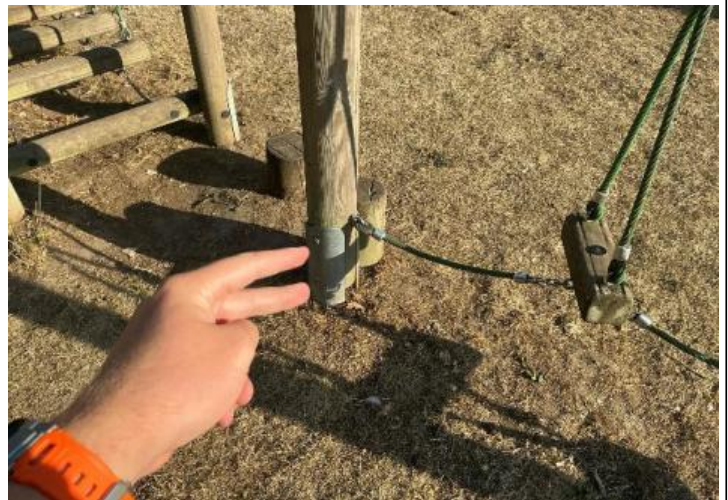
**Finding:** A number of fixing(s) have worked loose

**Action:** Secure all loose fixings
