## **MINUTES OF THE MEETING OF THE **PROPERTY COMMITTEE** HELD AT THE DRILL HALL ON TUESDAY 18<sup>th</sup> August 2026 AT 2PM**

**8. To Receive Update on Property Forward Maintenance Plan Project**

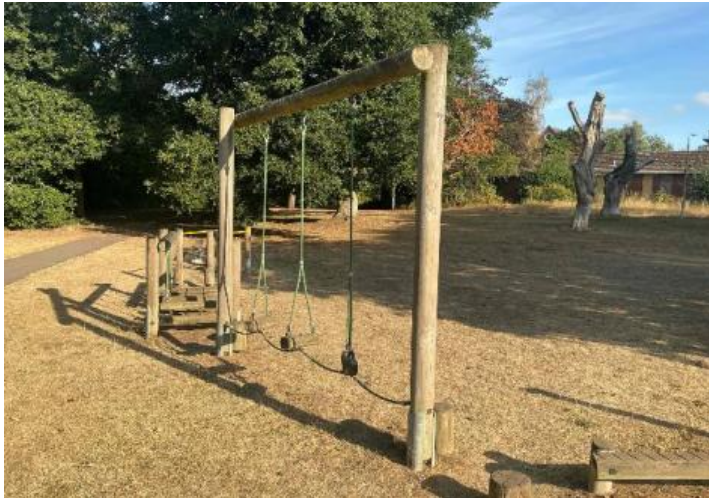
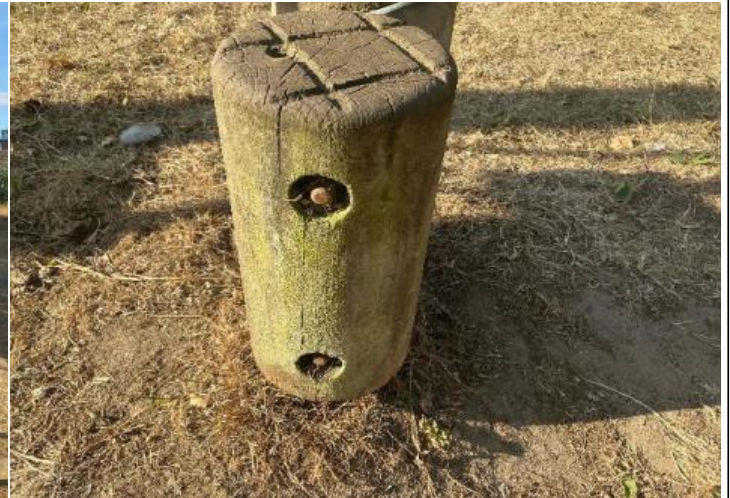
**Finding:** Bolt cap cover/s missing or damaged

**Action:** Replace

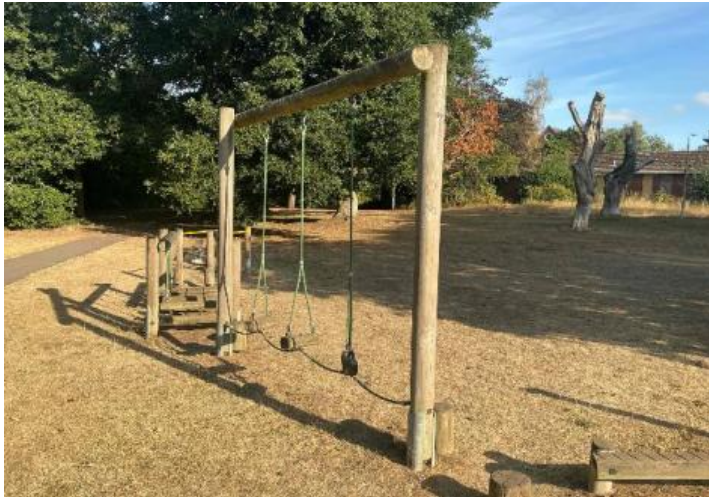
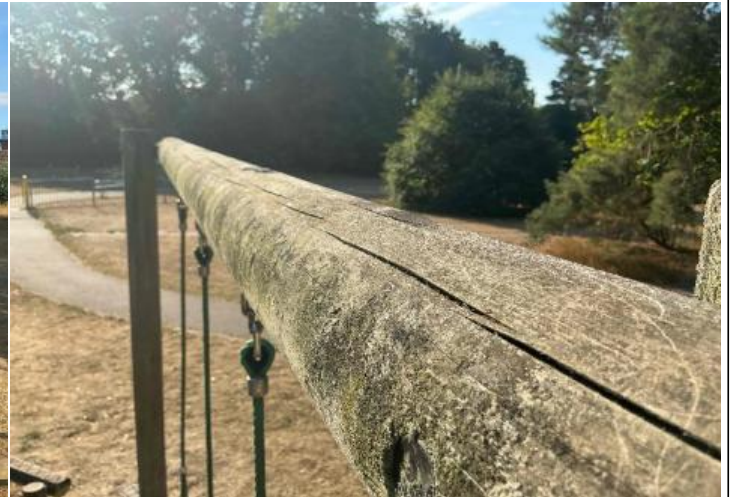
**Finding:** The timber has a number of splits/shakes or air cracks and this may affect the stability or allow water ingress which will accelerate the rotting process. Timber splits may also create rough / splintering edges.

**Action:** Monitor, sand down any rough edges and ensure the splits do not cross through fixing points of the structure and/or cause any instability

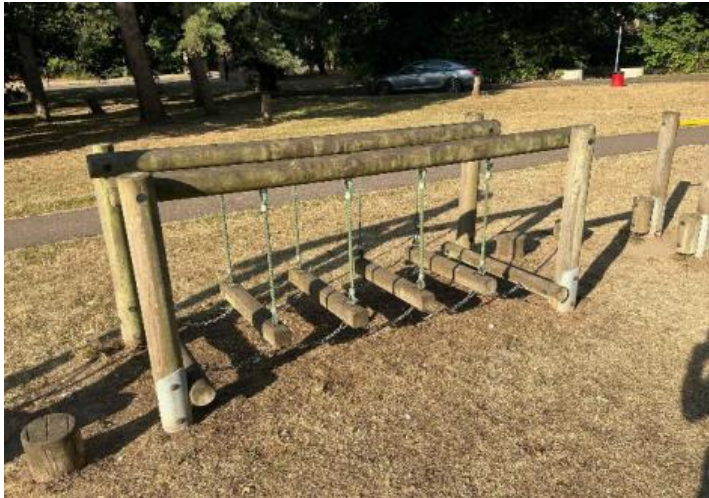
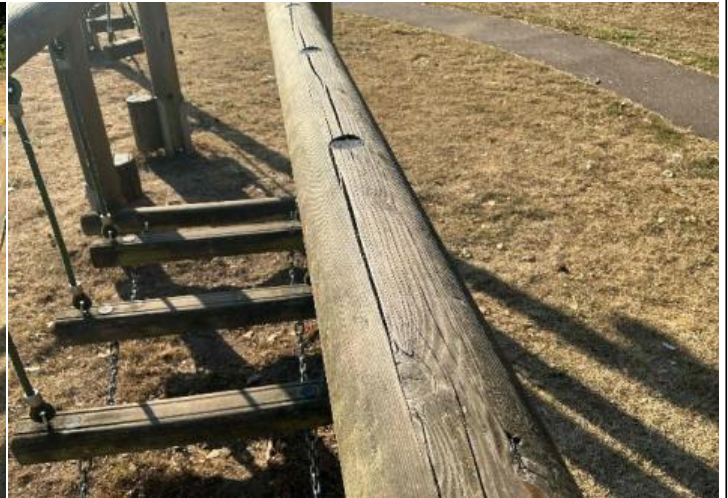
**Finding:** The timber has a number of splits/shakes or air cracks and this may affect the stability or allow water ingress which will accelerate the rotting process. Timber splits may also create rough / splintering edges.

**Action:** Monitor, sand down any rough edges and ensure the splits do not cross through fixing points of the structure and/or cause any instability

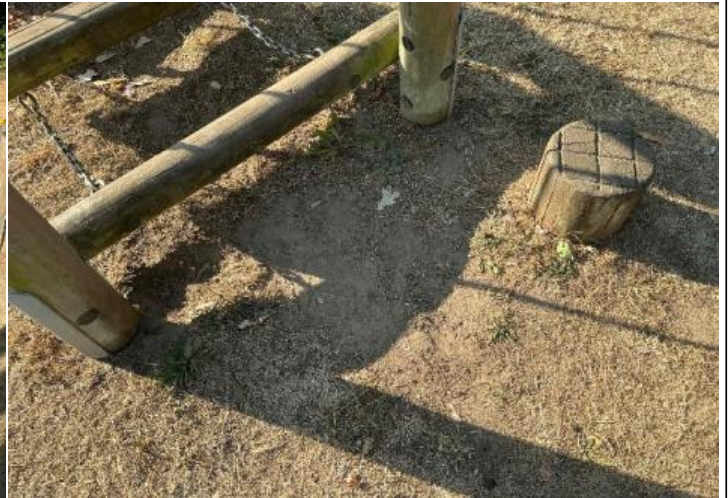
**Finding:** The surface has eroded in some areas and may be slippery in wet conditions  
**Action:** Reinstate the surface

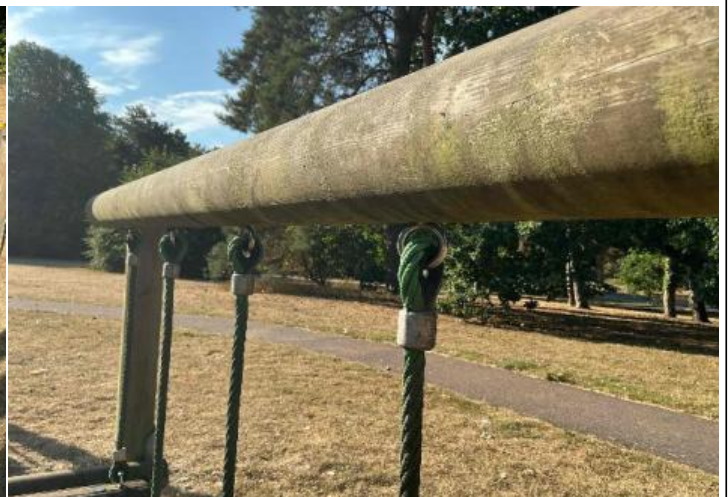
**Finding:** A number of eyebolt fixing(s) have worked loose  
**Action:** Secure all loose fixings

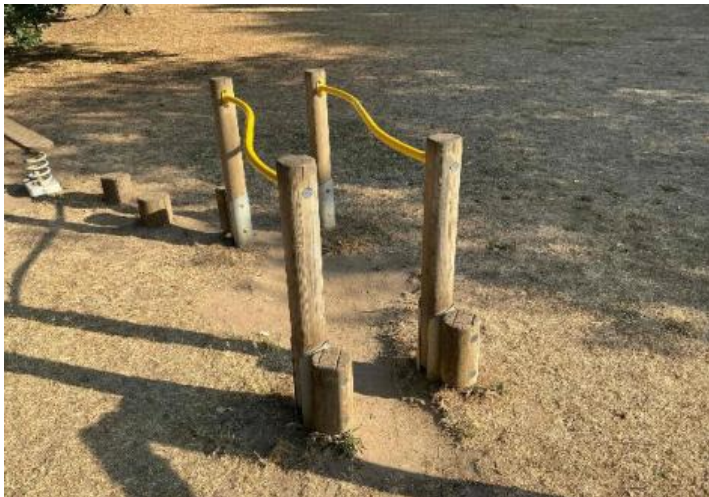
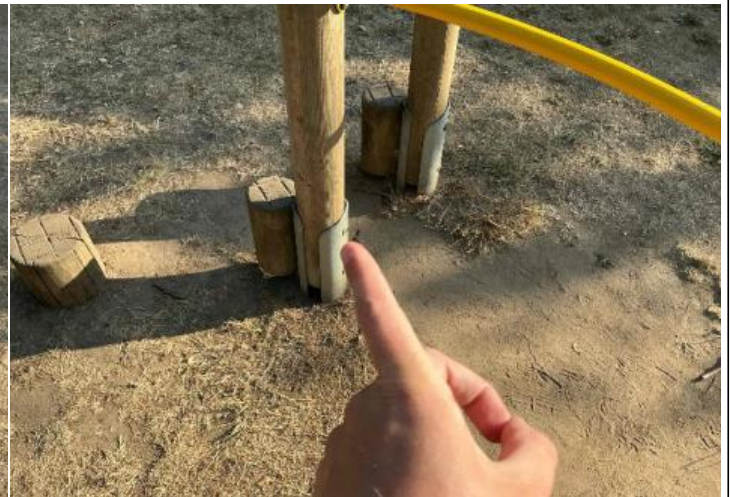
**Finding:** A number of fixing(s) have worked loose  
**Action:** Secure all loose fixings

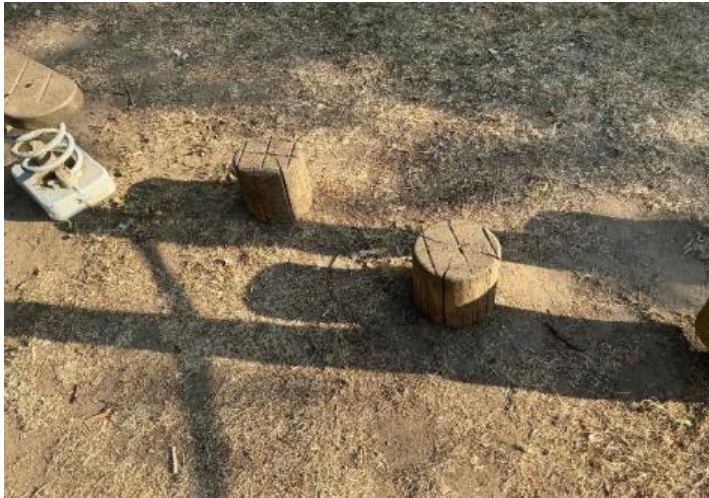
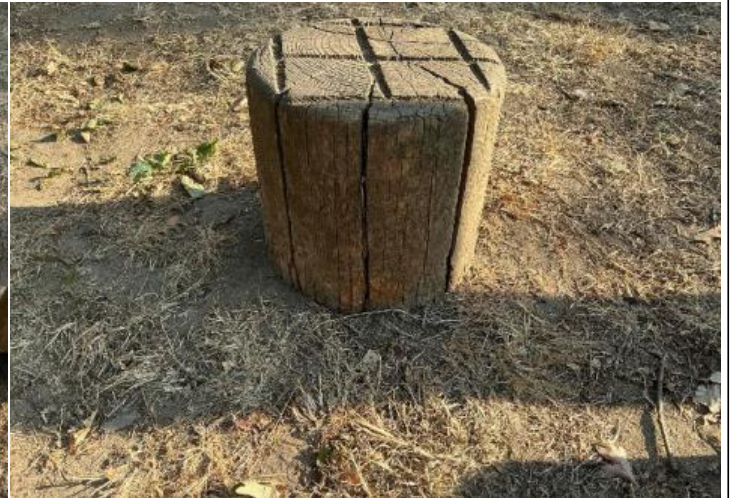
**Finding:** There is some strimmer / machinery damage apparent on the posts, this can penetrate the preservative applied to the timber and accelerate the rotting process

**Action:** Monitor for any deterioration (rot) and replace as required

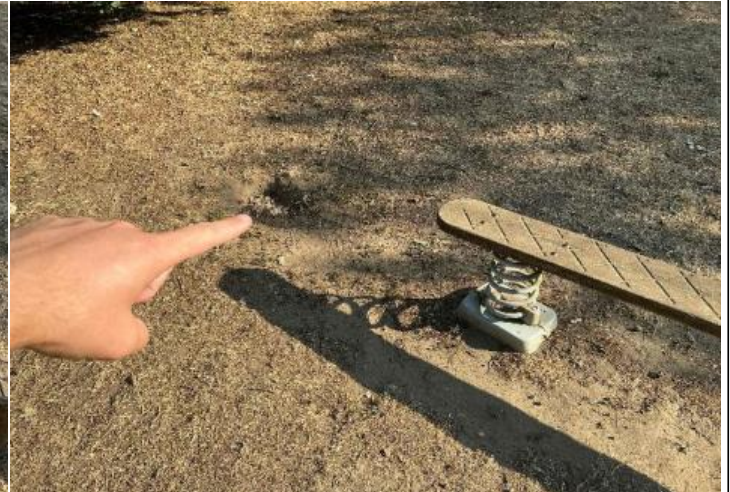
**Finding:** There are holes in the surface that may cause users to trip or roll ankles

**Action:** Infill to provide a sound reasonably level surface.
