## **MINUTES OF THE MEETING OF THE **PROPERTY COMMITTEE** HELD AT THE DRILL HALL ON TUESDAY 18<sup>th</sup> August 2026 AT 2PM**

**8. To Receive Update on Property Forward Maintenance Plan Project**

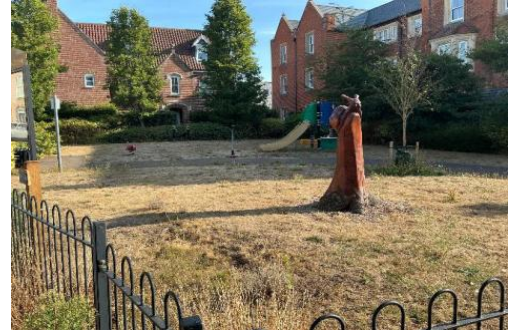
It is recommended that signage, with information including the site address, contact information for maintenance issues and emergency contact details are provided for the facility - Provide in accordance with the recommendations

There is some minor damage to the surface - Monitor for any further deterioration and repair as required

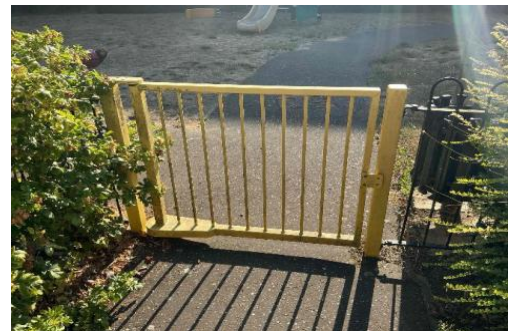
The gate is closing too quickly (less than 4 seconds) - Take corrective action to ensure that the gate closes in 4-8 seconds from 90 degrees

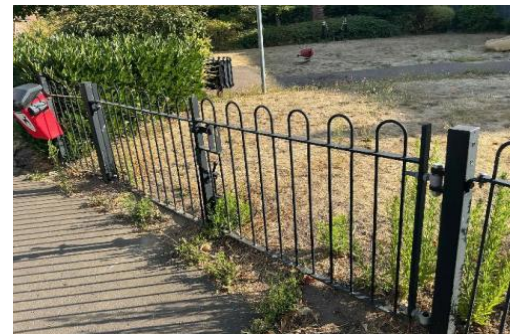
There is no padlock on the maintenance gate - Provide a padlock to secure the gate

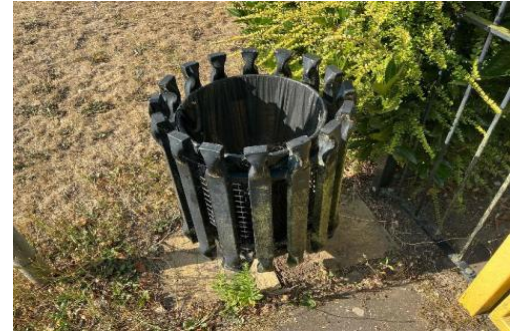
The liner of the litter bin is not secured and can be easily removed - Ensure the liner is secured

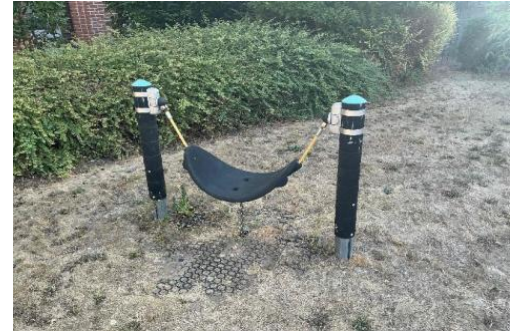
The grass mats are silted up, the soil is compacted and the area will become very slippery when the soil is wet. - Reinstate as required

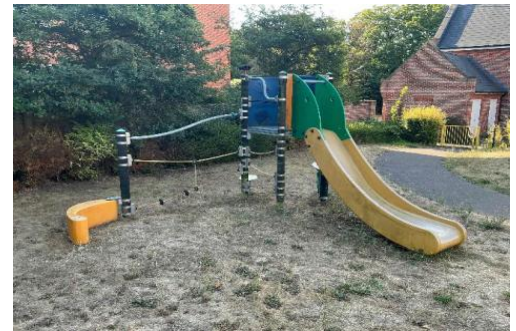
There is/are finger entrapment/s in the rings and the item fails to meet the requirements of BS EN 1176 Part 1 4.2.7.6  
 Entrapment of fingers - Monitor - No remedial work recommended

There is minor damage to the slide surface - Monitor for any further deterioration and repair as required

Bolt cap cover/s missing or damaged - Replace

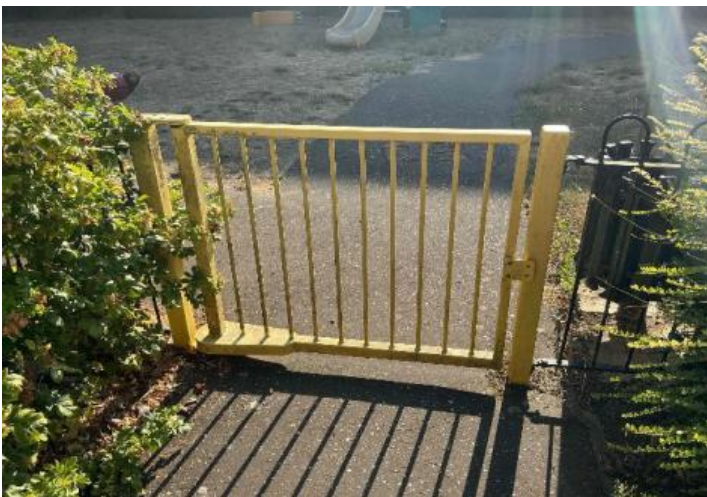
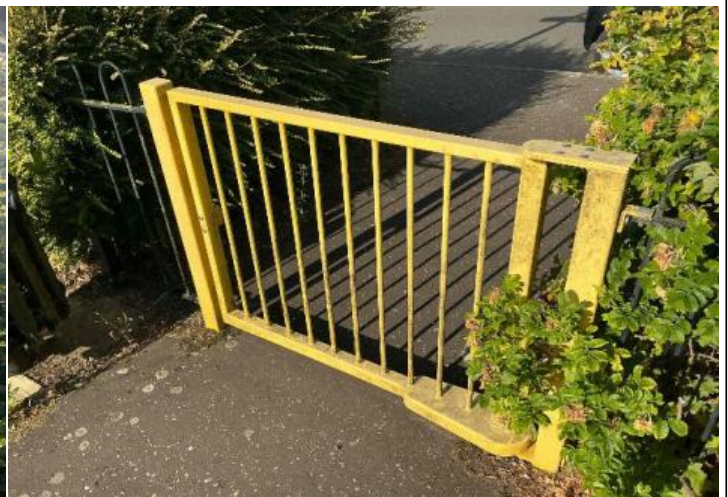
**Item:** Gates - Gate - Self Closing  
**Manufacturer:** I.A.E. Fencing

**Finding:** The gate is closing too quickly (less than 4 seconds)

**Action:** Take corrective action to ensure that the gate closes in 4-8 seconds from 90 degrees

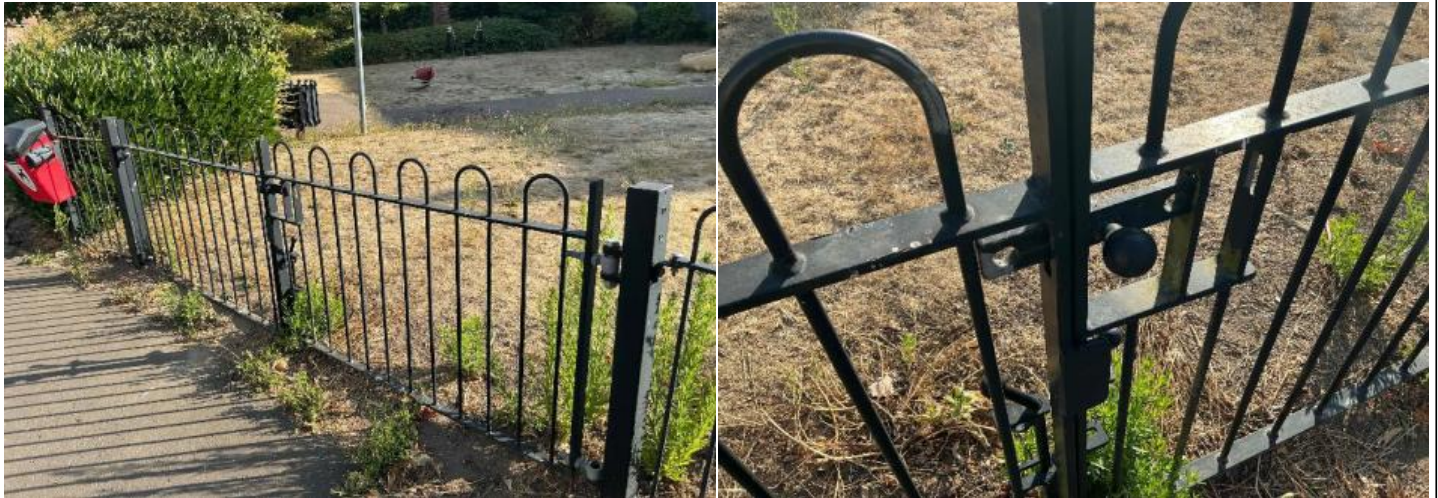
**Item:** Gates - Gate - Maintenance  
**Manufacturer:** Not Identified

**Finding:** There is no padlock on the maintenance gate

**Action:** Provide a padlock to secure the gate

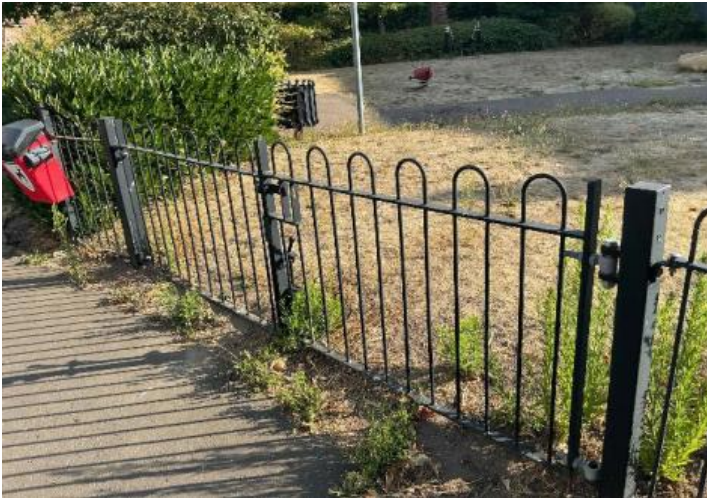
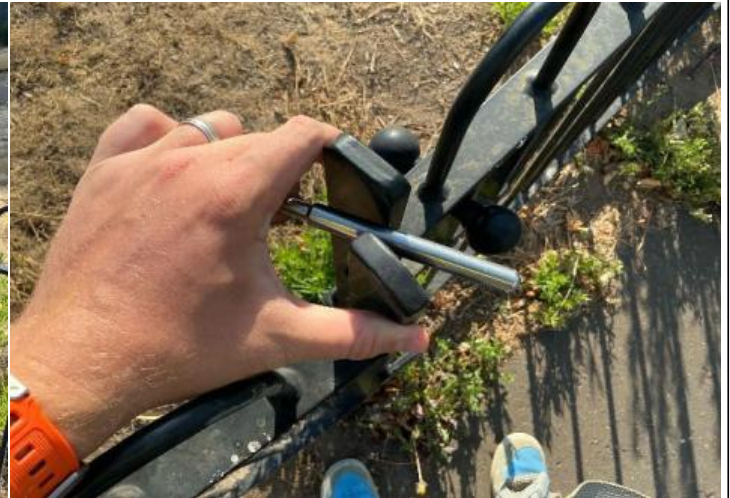
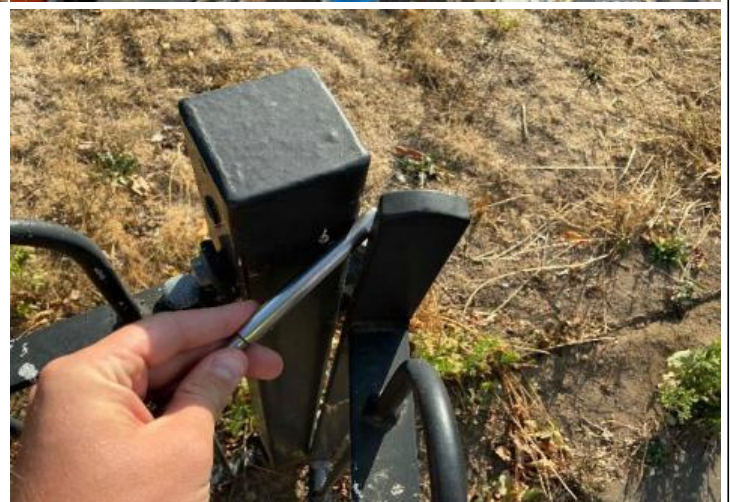
**Item:** Gates - Gate - Maintenance  
**Manufacturer:** Not Identified

**Finding:** There are openings that are less than 12mm that could trap or crush fingers

**Action:** Provide a 12mm gap throughout full range of motion at both sides of gate

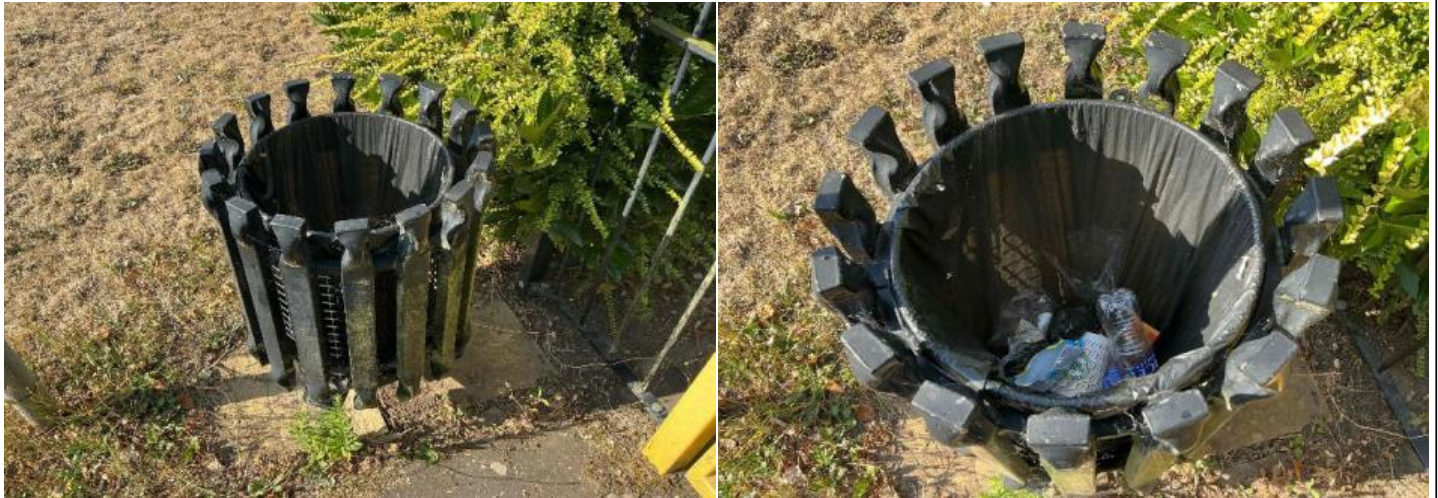
**Item:** Ancillary Items - Litter Bin  
**Manufacturer:** Not Identified

**Finding:** The liner of the litter bin is not secured and can be easily removed  
**Action:** Ensure the liner is secured

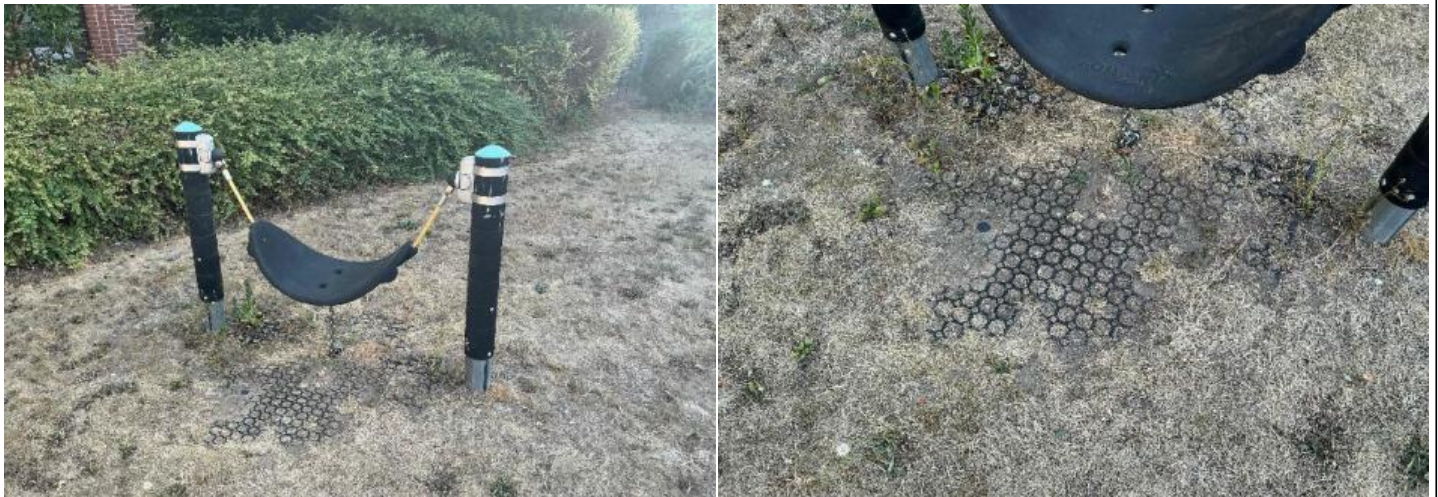
**Item:** Activity Equipment - Hammock - Under 1.3m  
**Manufacturer:** Kompan Ltd

**Finding:** The grass mats are silted up, the soil is compacted and the area will become very slippery when the soil is wet.  
**Action:** Reinstate as required

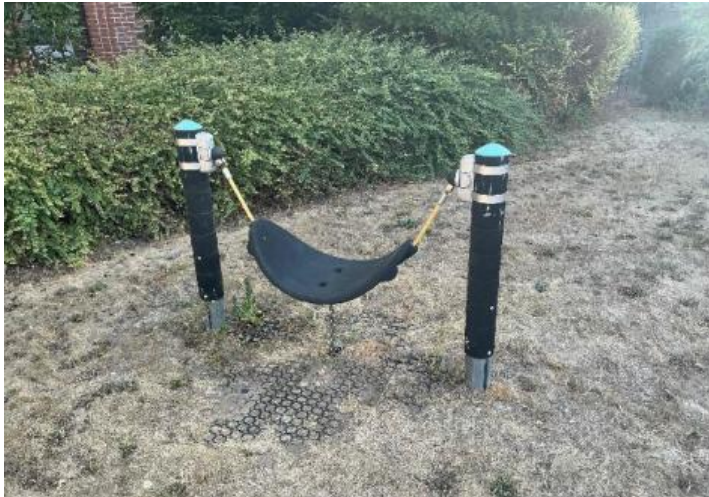
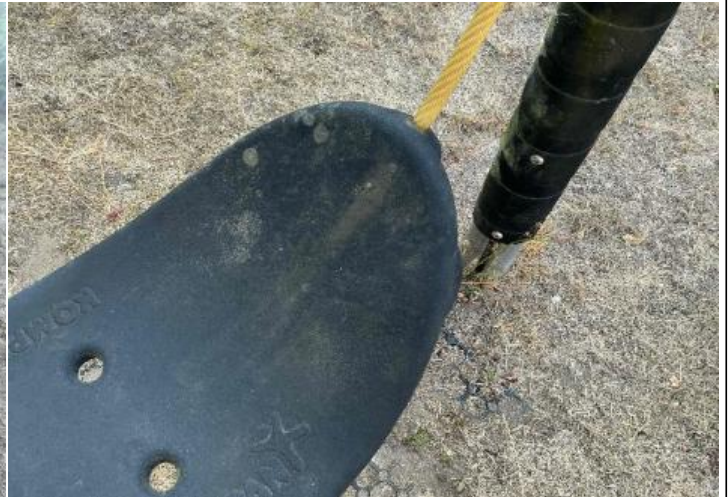
**Item:** Activity Equipment - Hammock - Under 1.3m  
**Manufacturer:** Kompan Ltd

**Finding:** There is algae or moss on the surface of the equipment

**Action:** Clean and treat appropriately

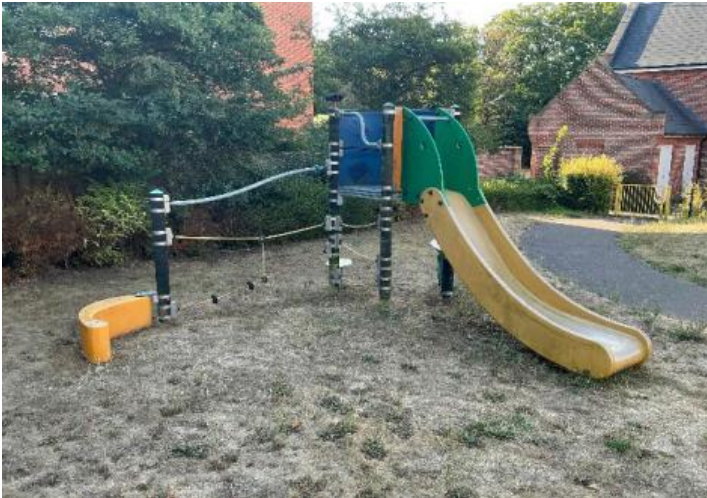
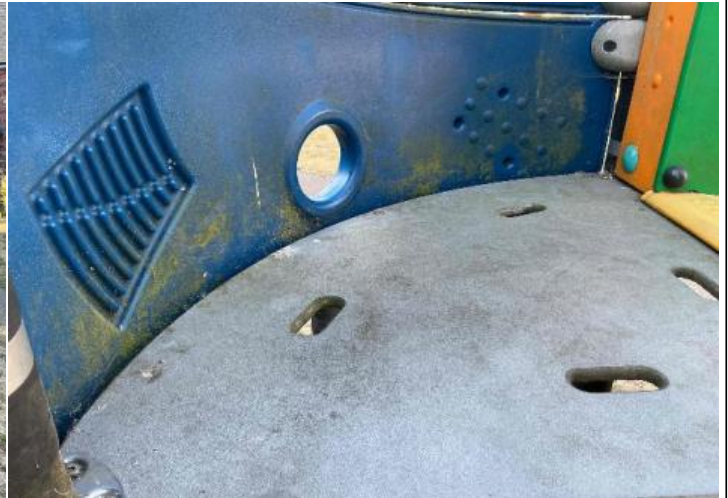
**Item:** Activity Equipment - Multi Play (Junior)  
**Manufacturer:** Kompan Ltd

**Finding:** There is algae or moss on the surface of the equipment

**Action:** Clean and treat appropriately

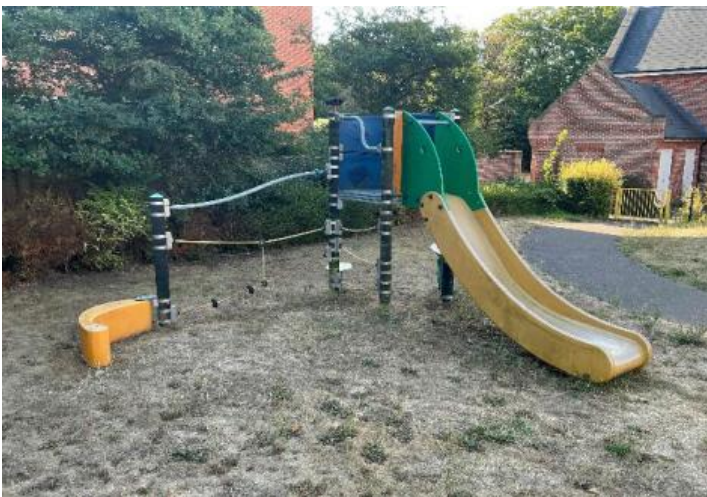
**Item:** Activity Equipment - Multi Play (Junior)  
**Manufacturer:** Kompan Ltd

**Finding:** There is minor damage to the slide surface

**Action:** Monitor for any further deterioration and repair as required

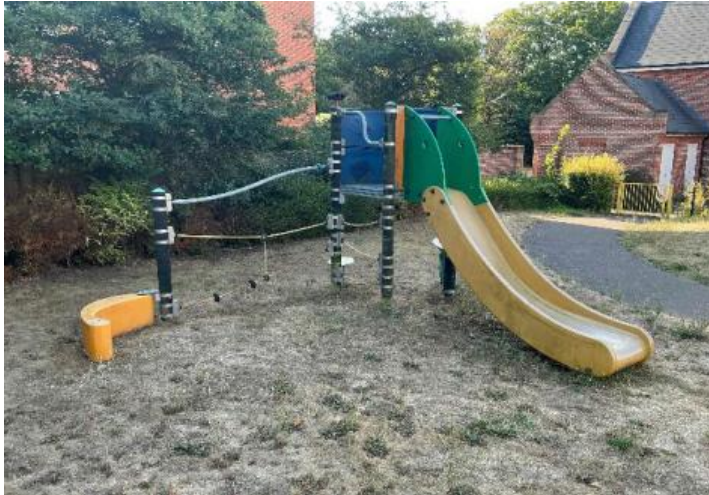
**Item:** Activity Equipment - Multi Play (Junior)  
**Manufacturer:** Kompan Ltd

**Finding:** Bolt cap cover/s missing or damaged

**Action:** Replace

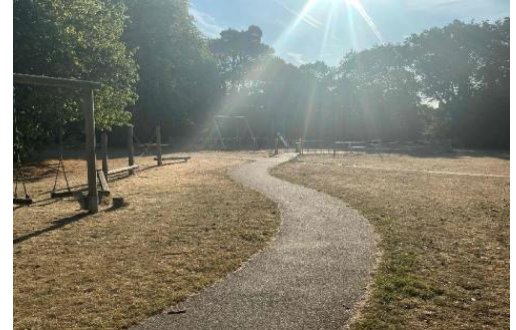
It is recommended that signage, with information including the site address, contact information for maintenance issues and emergency contact details are provided for the facility - Provide in accordance with the recommendations

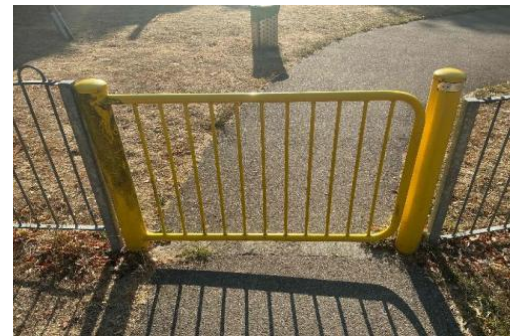
There is or are fixings missing on the item - Replace all missing fixings

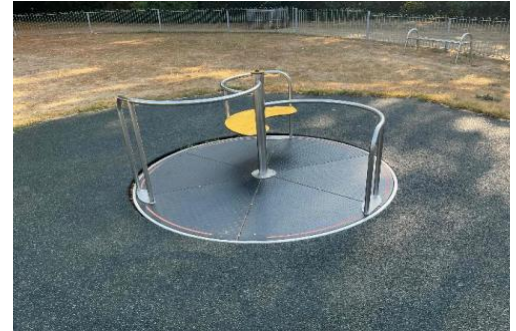
The surface is lifting at the edges and creating trip points - Repair perimeter of surfacing to remove trip points

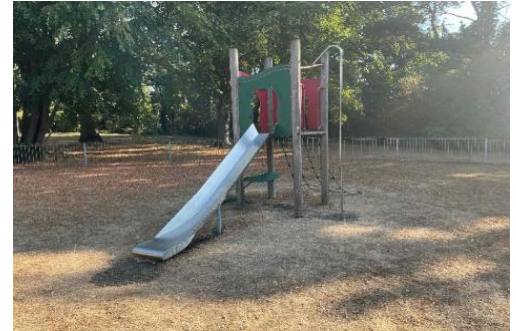
The grass mats are silted up, the soil is compacted and the area will become very slippery when the soil is wet. - Reinstate as required

Bolt cap cover/s missing or damaged - Replace

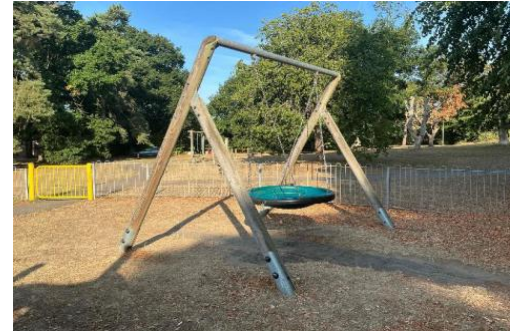
The grass mats are silted up and the soil is compacted; this may have an effect on the impact absorbing properties of the surface. Consideration should be given to HIC testing the surface to verify impact attenuating properties ( <https://playinspections.co.uk/inspection-services/safety-surface-testing/> ) - Contact our office for a quotation for this service

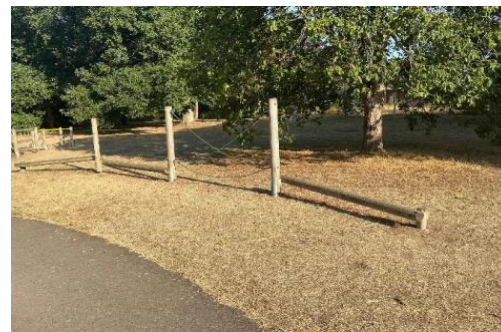
The tree canopy overhangs the equipment and is less than 2.0m away - Lift tree canopy to ensure a minimum clearance of 2.0m from the equipment

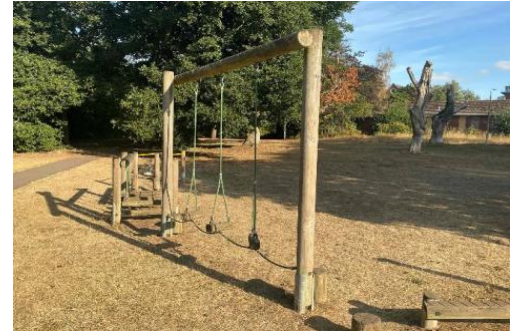
There is algae or moss on the surface of the equipment which can lead to the onset of rot - Clean and treat appropriately and monitor condition of the timber

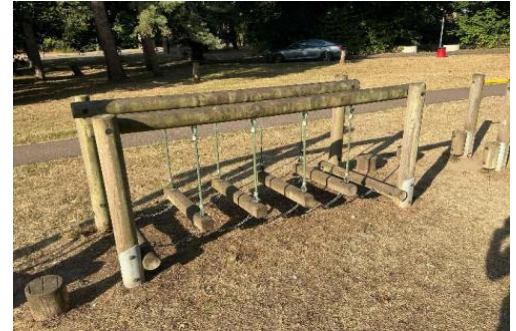
The timber has a number of splits/shakes or air cracks and this may affect the stability or allow water ingress which will accelerate the rotting process. Timber splits may also create rough / splintering edges. - Monitor, sand down any rough edges and ensure the splits do not cross through fixing points of the structure and/or cause any instability

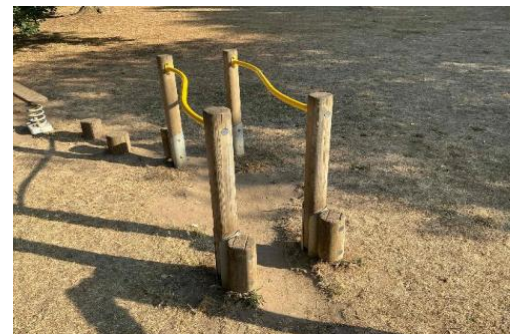
**i 8 - Low Risk**

The grass has eroded within the impact area of the equipment and may not provide the necessary impact attenuating properties for the equipment fall height; the surface may also be slippery in wet weather - Reinstate the grass or provide an all weather surface

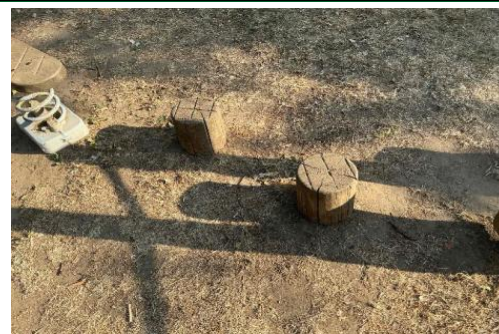
There is some strimmer / machinery damage apparent on the posts, this can penetrate the preservative applied to the timber and accelerate the rotting process - Monitor for any deterioration (rot) and replace as required

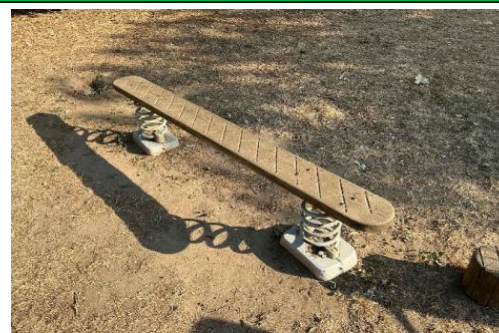
The grass has eroded within the impact area of the equipment and may not provide the necessary impact attenuating properties for the equipment fall height; the surface may also be slippery in wet weather - Reinstate the grass or provide an all weather surface

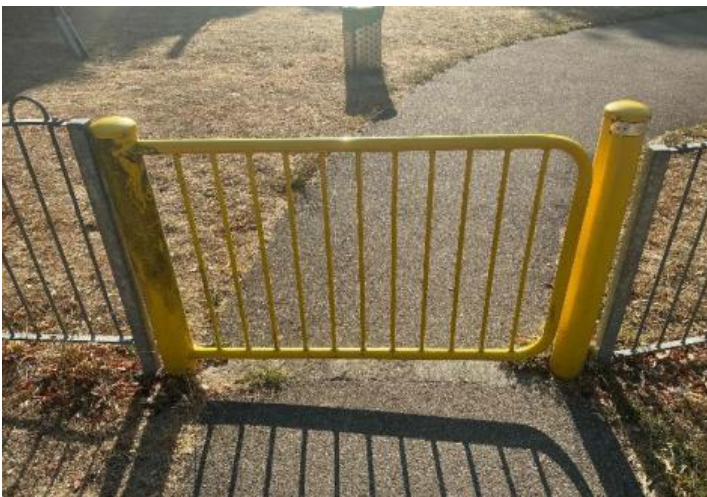
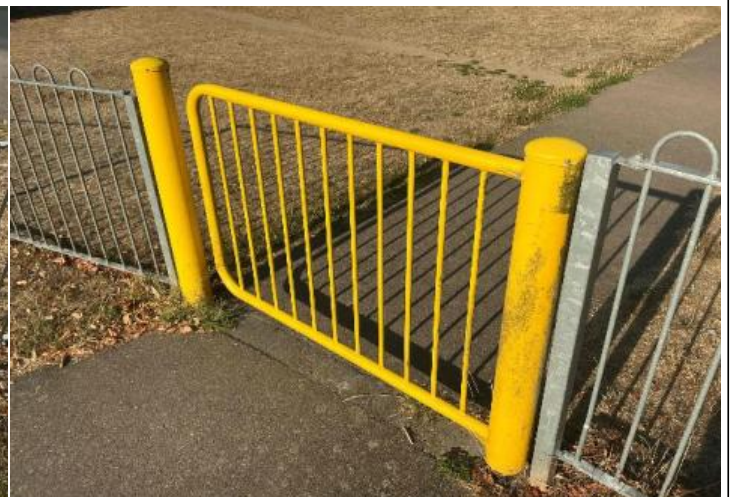
**Finding:** The gate is closing too slowly (in excess of 8 seconds)

**Action:** Take effective action to ensure the gate closes between 4 and 8 seconds from 90 degrees

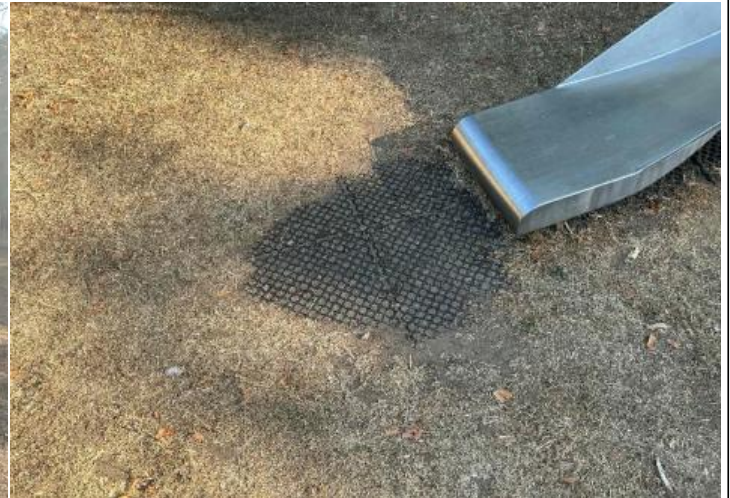
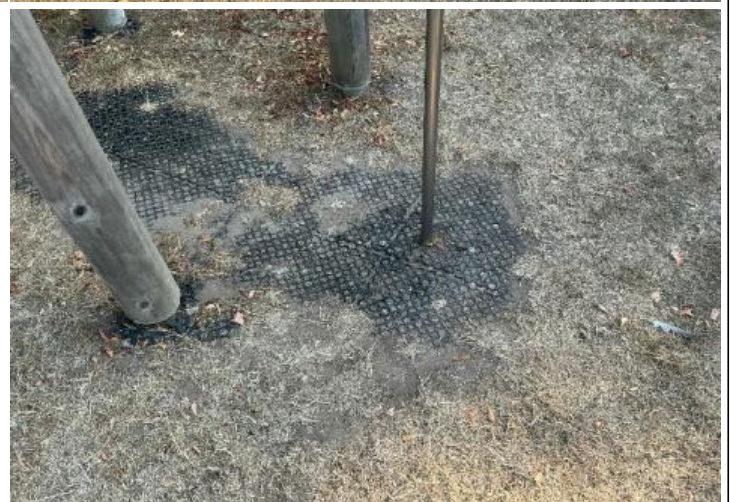
**Finding:** The grass mats are silted up, the soil is compacted and the area will become very slippery when the soil is wet. **Action:** Reinstate as required

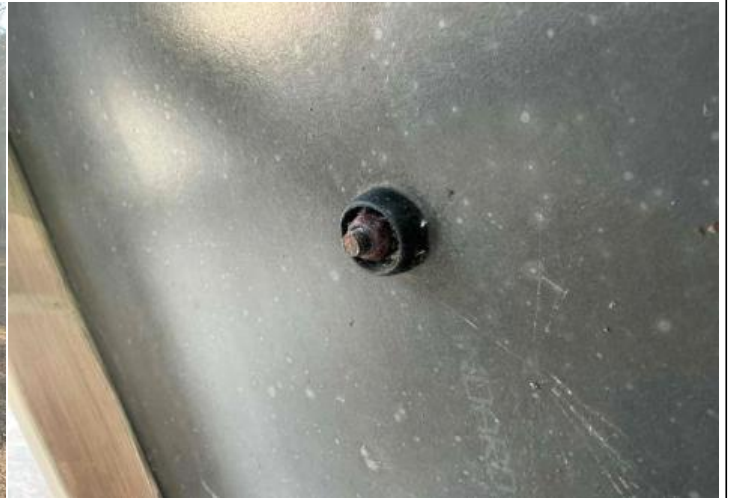
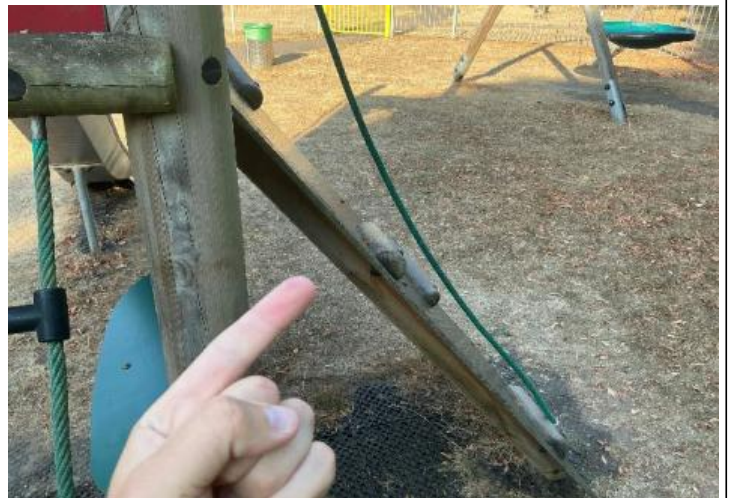
**Finding:** There are projecting bolt thread(s) present

**Action:** Remove excess thread length and deburr or provide cap

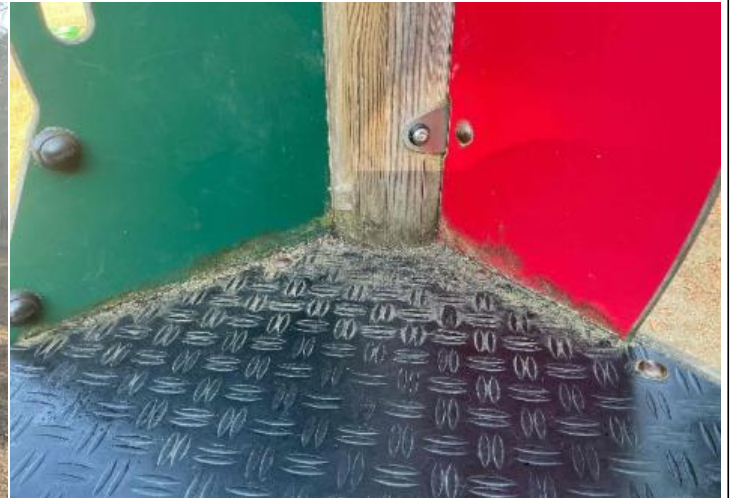
**Finding:** There is algae or moss on the surface of the equipment

**Action:** Clean and treat appropriately

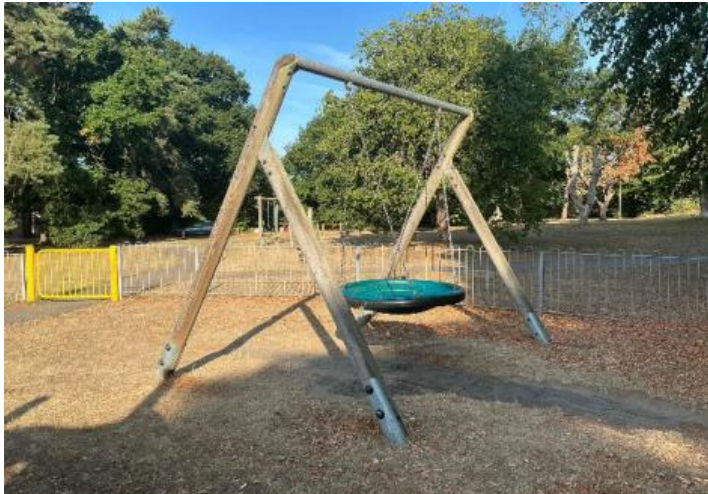
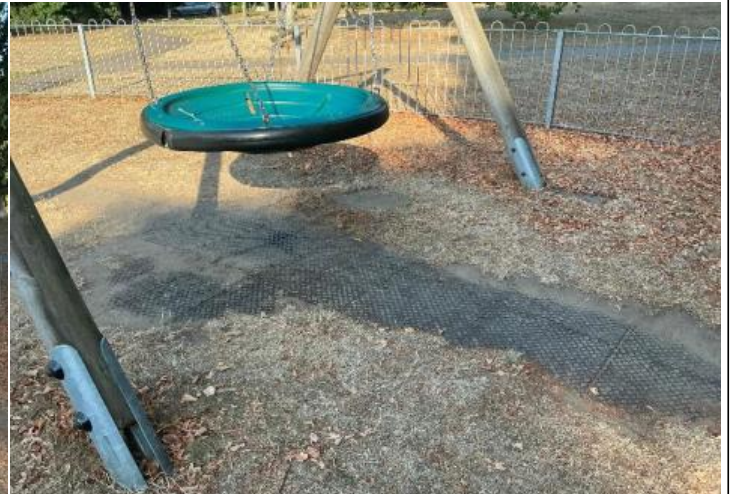
**Finding:** The grass mats are silted up and the soil is compacted; this may have an effect on the impact absorbing properties of the surface. Consideration should be given to HIC testing the surface to verify impact attenuating properties ( <https://playinspections.co.uk/inspection-services/safety-surface-testing/> )

**Action:** Contact our office for a quotation for this service

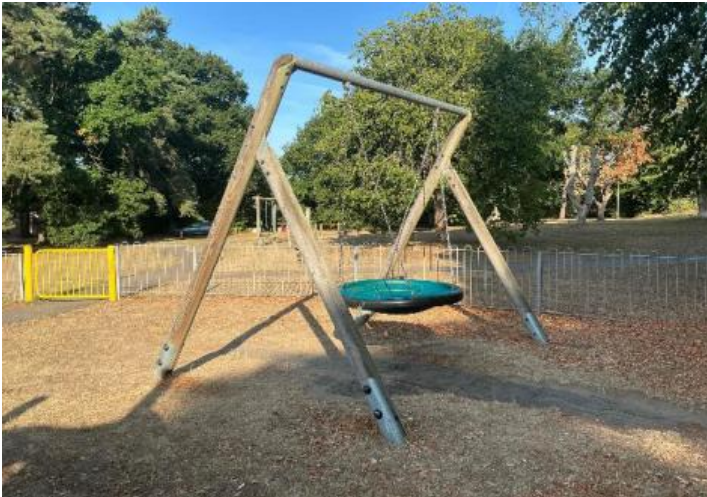
**Finding:** Swings of this design should have a secondary safety mechanism fitted to prevent collapse of the seat in the regularly event of a joint failure to comply with BS EN 1176 Part 2, however this swing was installed prior to the standards being updated in 2018 and the manufacturer has confirmed that the joint was independently cycle tested by BSi

**Action:** Monitor use and check the joint and fixing security

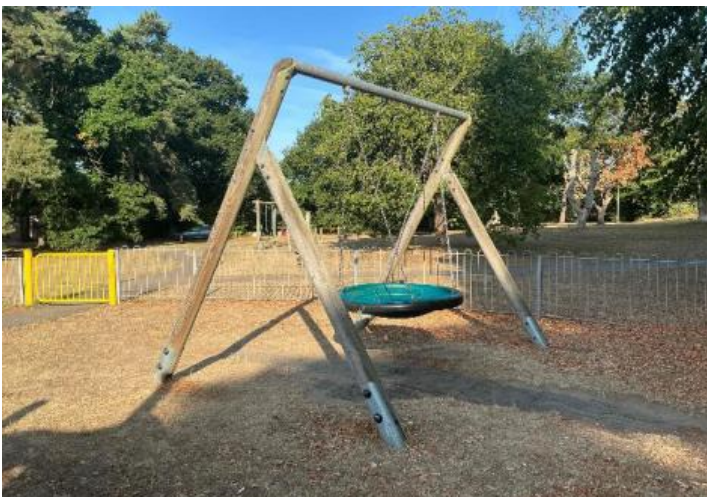
The fixings have corroded excessively - Replace all corroded fixings

**Finding:** The fixings have corroded excessively **Action:** Replace all corroded fixings

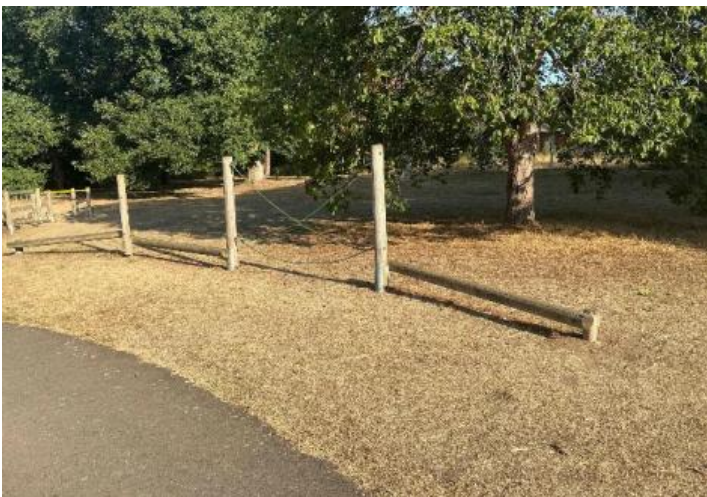
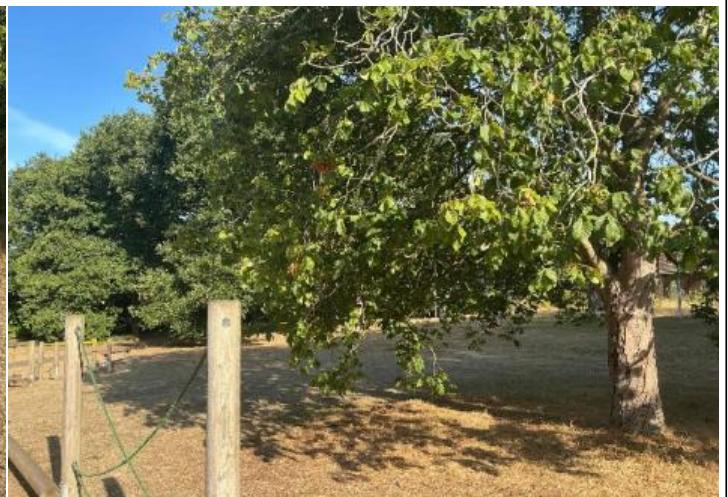
**Finding:** The tree canopy overhangs the equipment and is less than 2.0m away

**Action:** Lift tree canopy to ensure a minimum clearance of 2.0m from the equipment

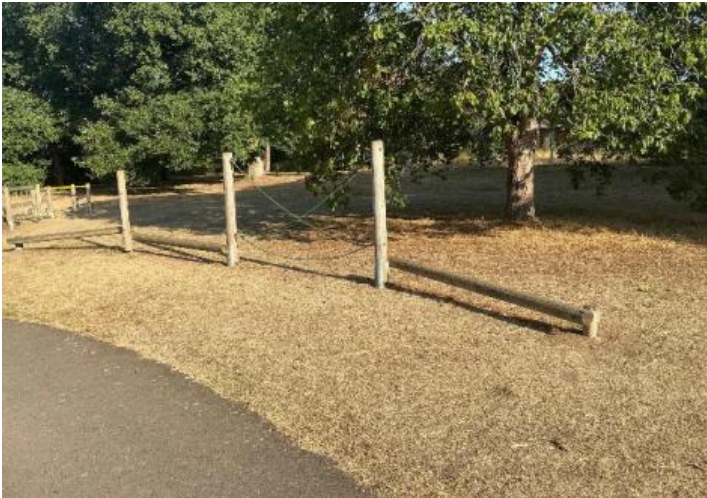
The surface has eroded and the foundations are exposed - Reinstate surrounding surfaces to cover the foundations

**Finding:** The surface has eroded and the foundations are exposed

**Action:** Reinstall surrounding surfaces to cover the foundations

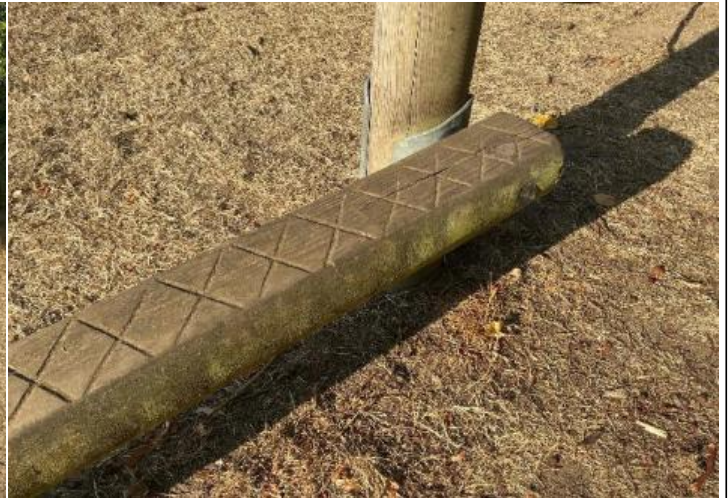
**Finding:** There is algae or moss on the surface of the equipment

**Action:** Clean and treat appropriately

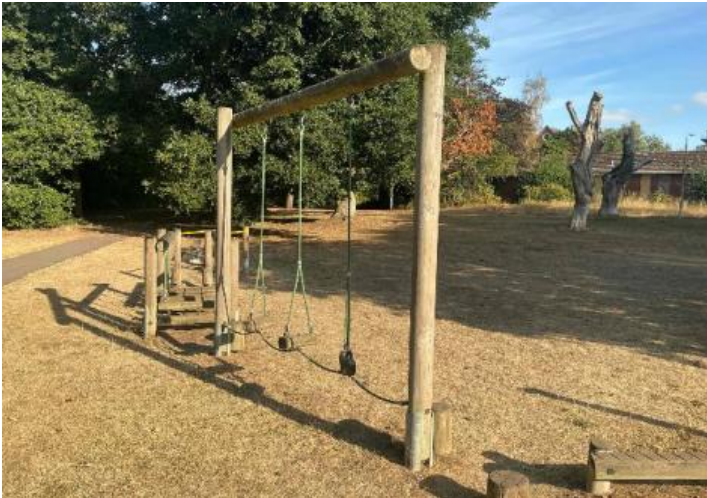
**Finding:** There is algae or moss on the surface of the equipment which can lead to the onset of rot

**Action:** Clean and treat appropriately and monitor condition of the timber

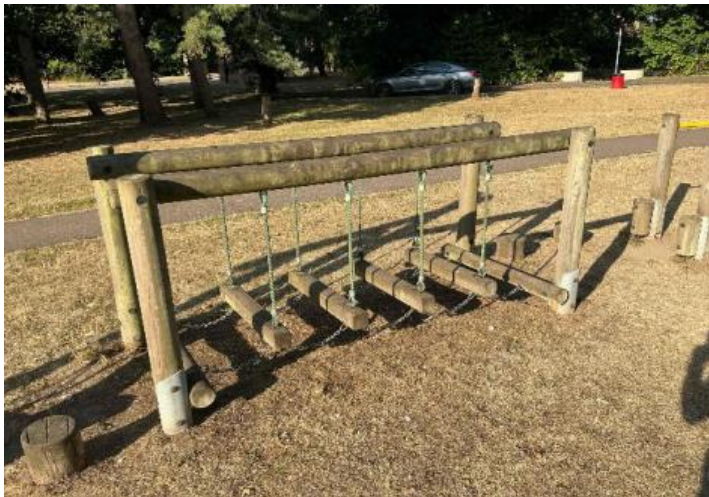
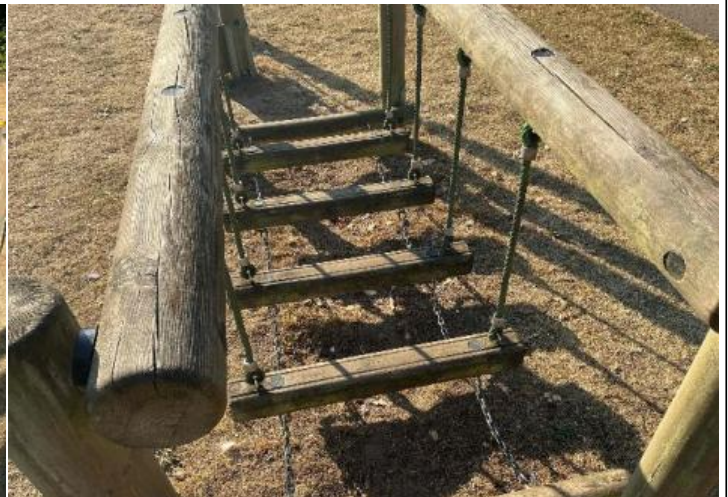
**Finding:** There is algae or moss on the surface of the equipment

**Action:** Clean and treat appropriately

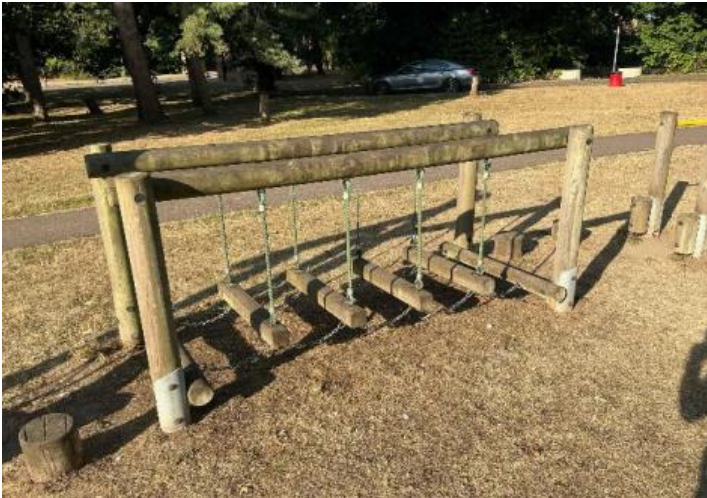
The surface has eroded in some areas and may be slippery in wet conditions - Reinstate the surface

**Finding:** The surface has eroded in some areas and may be slippery in wet conditions  
**Action:** Reinstate the surface

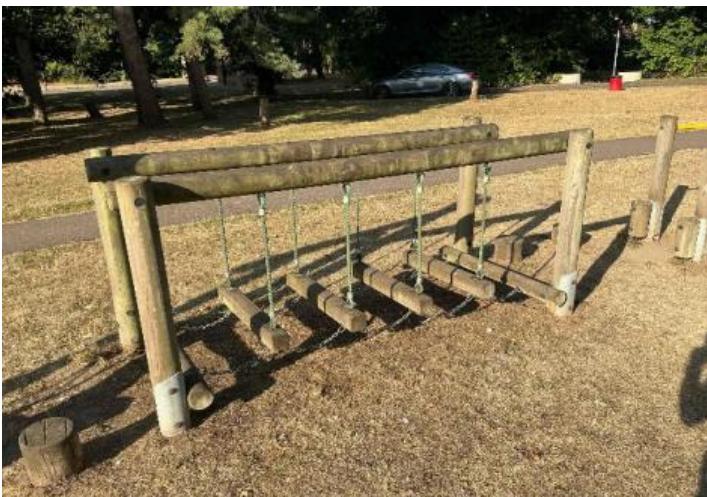
A number of eyebolt fixing(s) have worked loose - Secure all loose fixings

**Finding:** A number of eyebolt fixing(s) have worked loose  
**Action:** Secure all loose fixings

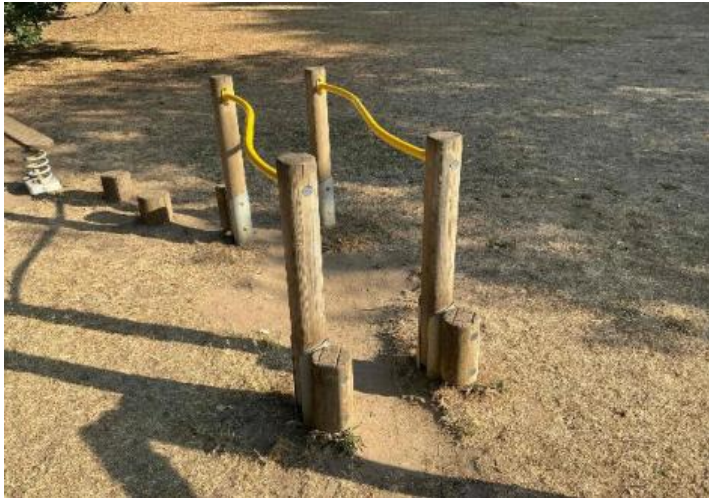
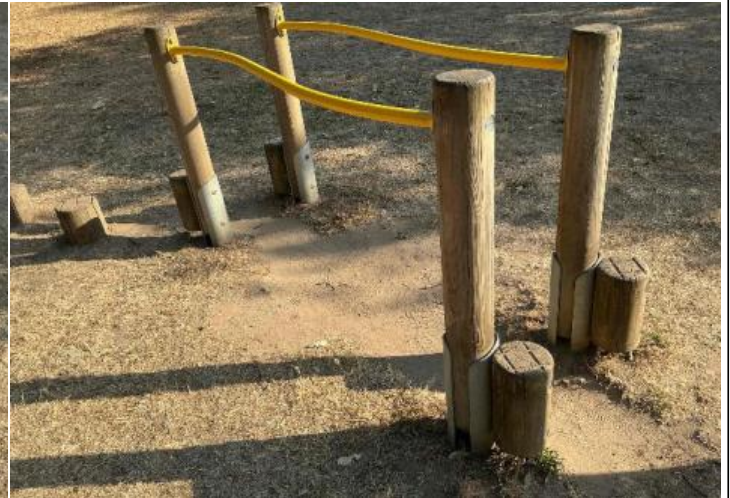
**Finding:** The grass has eroded within the impact area of the equipment and may not provide the necessary impact attenuating properties for the equipment fall height; the surface may also be slippery in wet weather  
**Action:** Reinststate the grass or provide an all weather surface

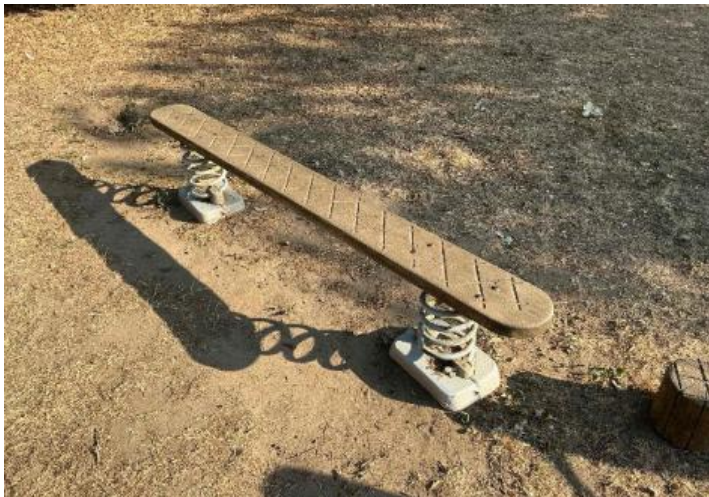
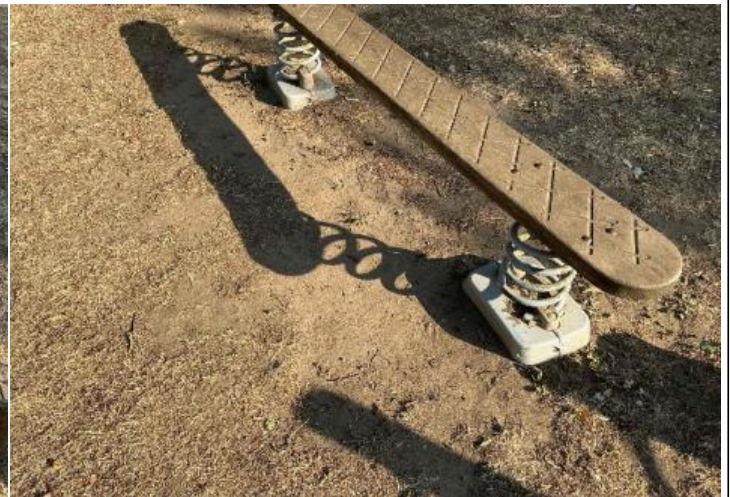
**Finding:** The grass has eroded within the impact area of the equipment and may not provide the necessary impact attenuating properties for the equipment fall height; the surface may also be slippery in wet weather

**Action:** Reinstate the grass or provide an all weather surface

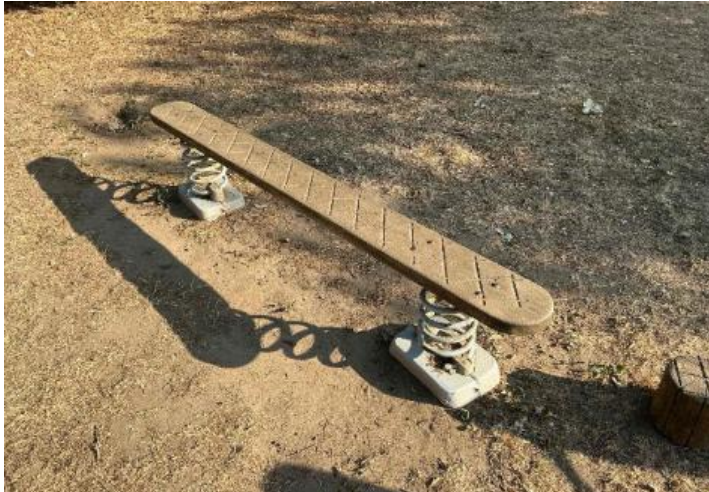
**Finding:** There are holes in the surface that may cause users to trip or roll ankles

**Action:** Infill to provide a sound reasonably level surface.
